# Structural Condition Assessment

## Former Schatz Manufacturing Co. Building Campus

Fairview Avenue, Poughkeepsie NY

Date: June 28th, 2024

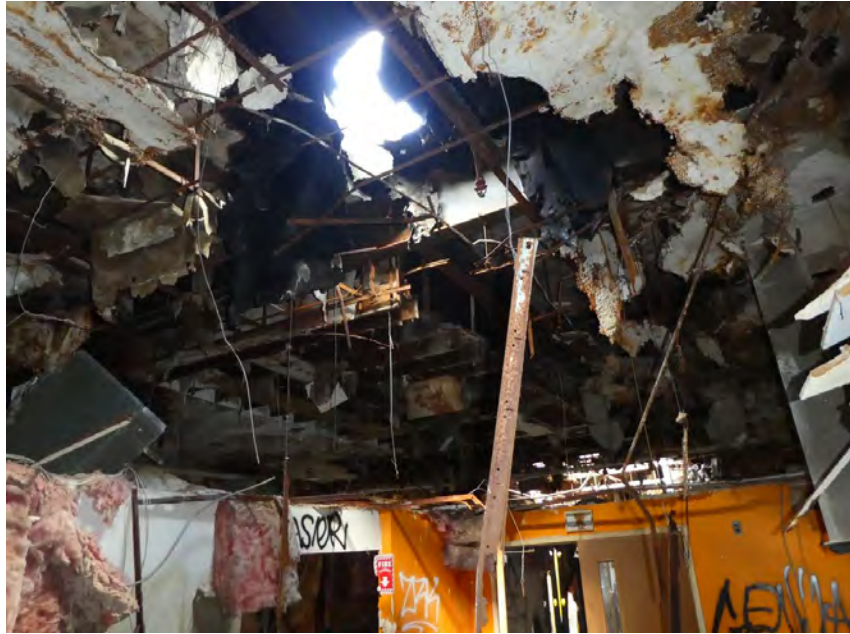
*Photo 6: Building 6, looking north up at collapsed roof.*

- 1.1.1 Building 6 is in unsafe condition due to the failure of the poured gypsum roof and the southern entry canopy, as well as the extent of deterioration of the floor. Building 6 should be demolished.

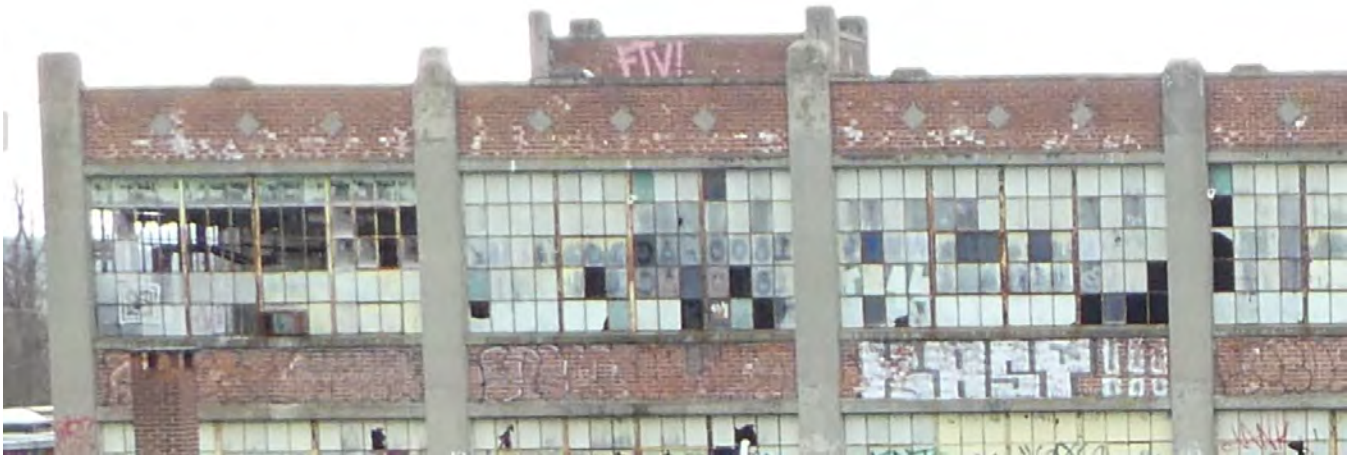
*Photo 24: South elevation of Building 1. Deteriorated concrete lintels, columns, column capitals and parapet copings.*

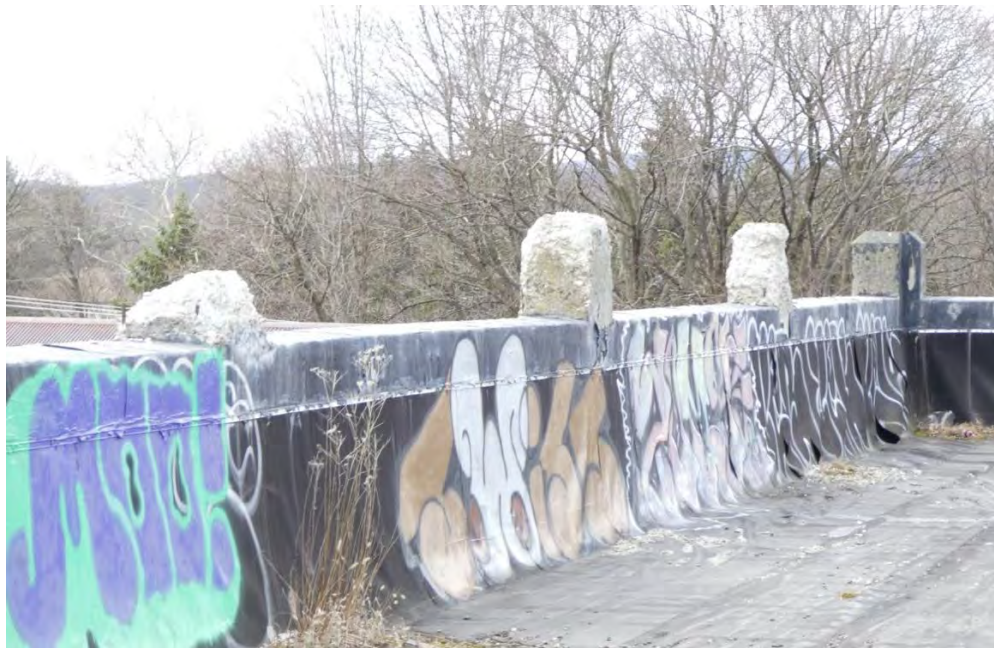
*Photo 25: Building 1 South parapet wall; deteriorated column capitals.*

- 1.1.7 There are several concrete column caps on top of the exterior masonry columns on Building 1 that are in poor condition and should be removed or replaced.
- 1.1.8 The concrete stair landing and concrete landing beam in Building 1 south stair should be repaired.
- 1.1.9 All the concrete slabs at Building 1 exhibit a concerning level of cracks, calcified stalactites along the bottoms of the slab, staining, and organic growth. These are all likely caused by repeated water infiltration into the building. Replacement of the roofing system and proper flashings should help with restricting the

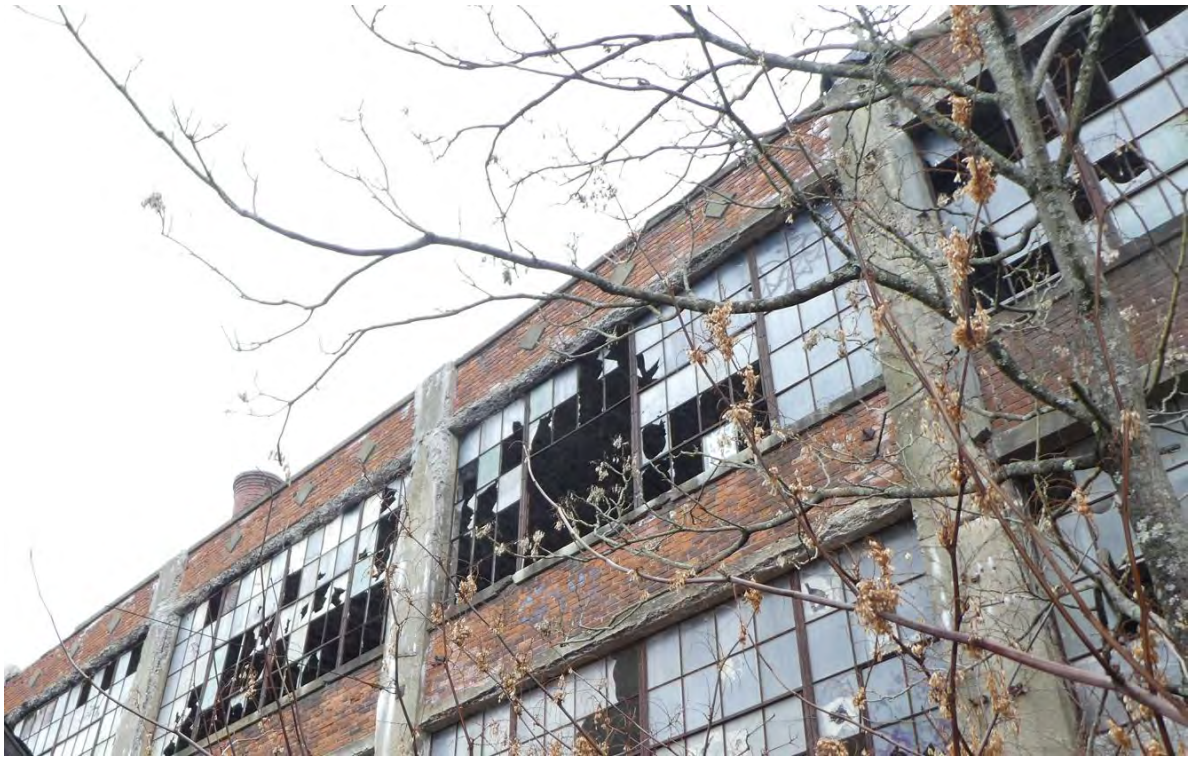
*Photo 26: North Elevation Building 10, Third Floor. Deteriorated concrete columns, lintels, copings.*

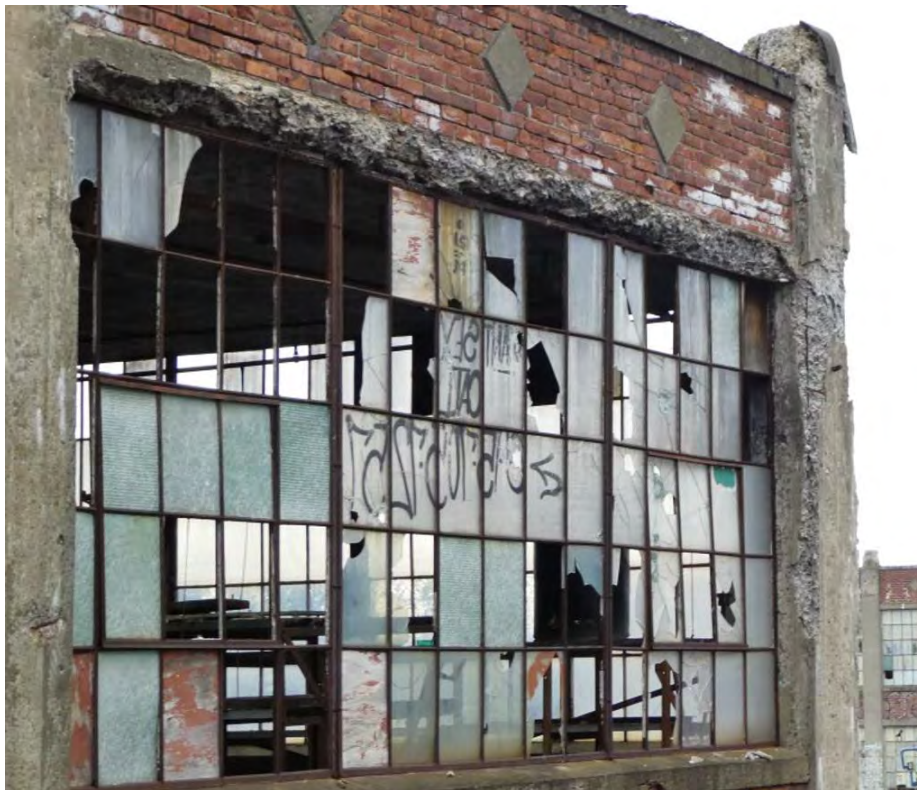
*Photo 27: East Elevation Building 10, Third Floor. Deteriorated concrete columns, lintels, copings.*

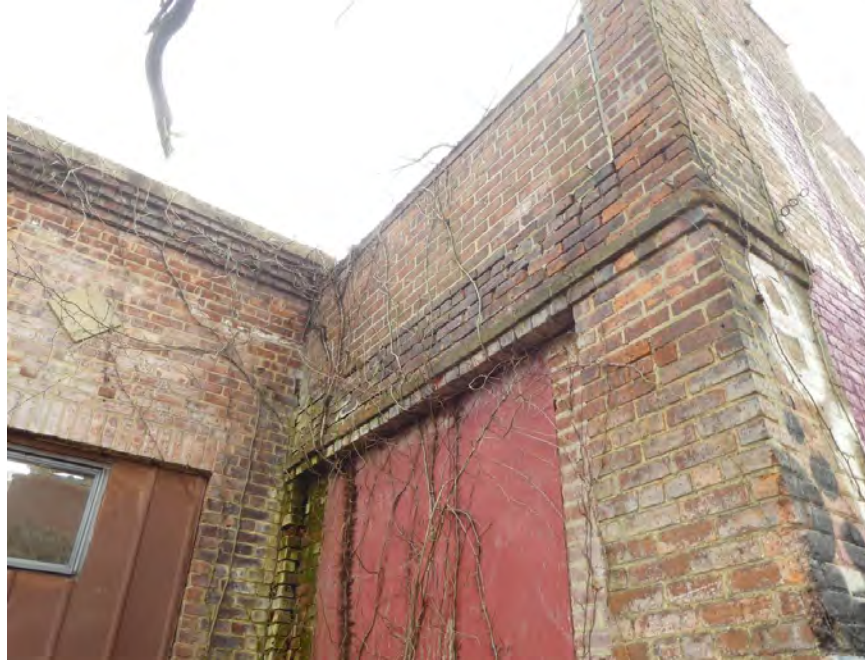
*Photo 28: North Elevation Building 9. Typical occurrence of organic staining (algae, vines) and graffiti.*

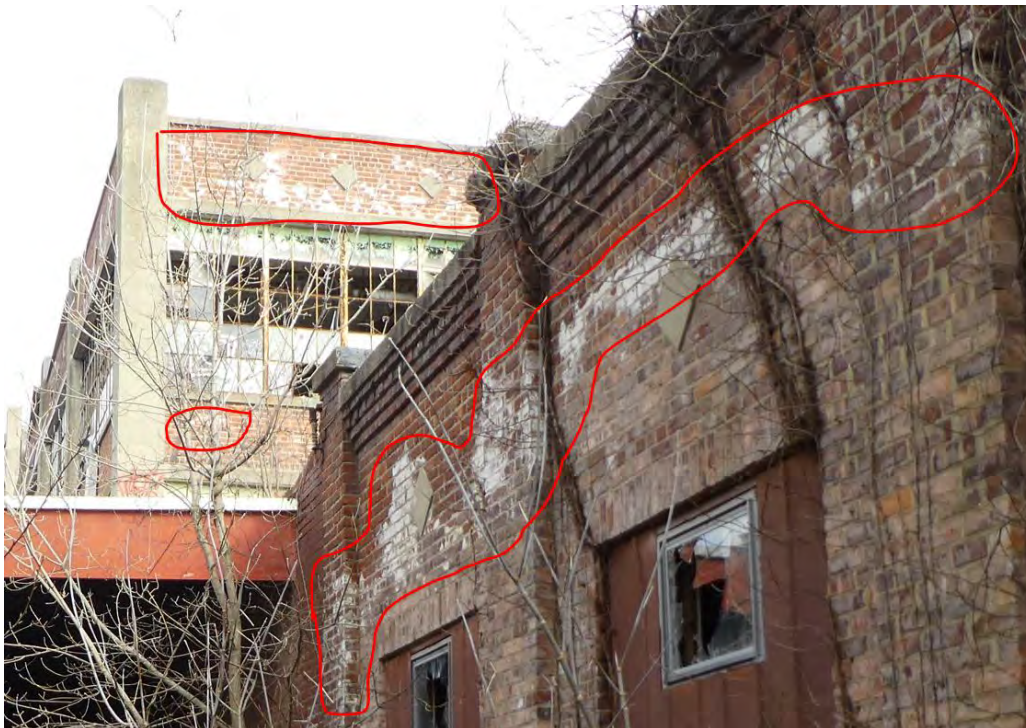
*Photo 29: South Elevation Building 1/West Elevation Building 2. Typical occurrence of efflorescence in masonry walls.*

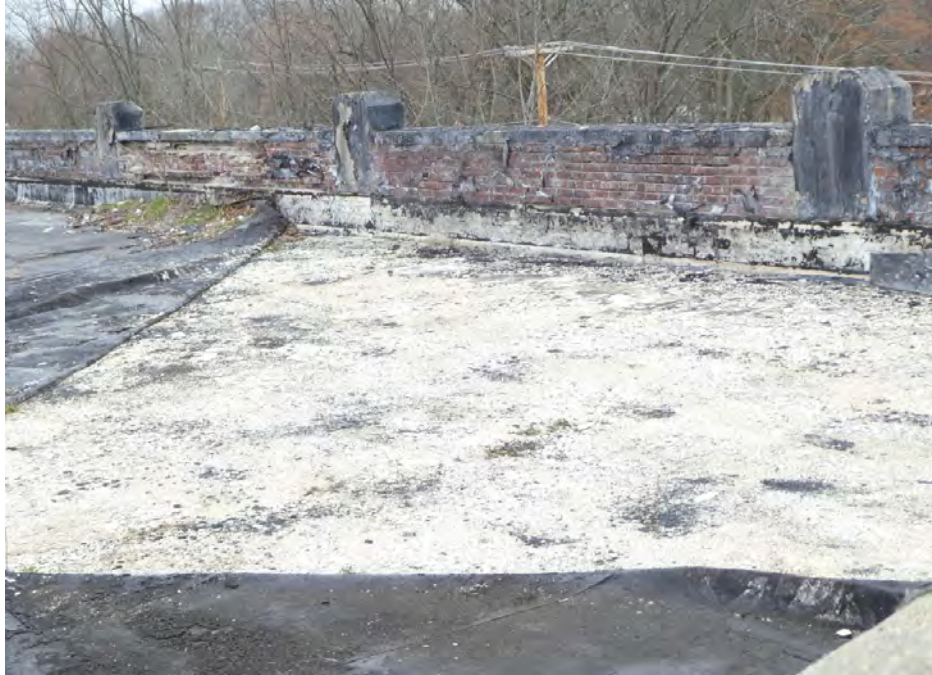
*Photo 30: Building 14, existing membrane roof pulled from roof deck and parapet.*

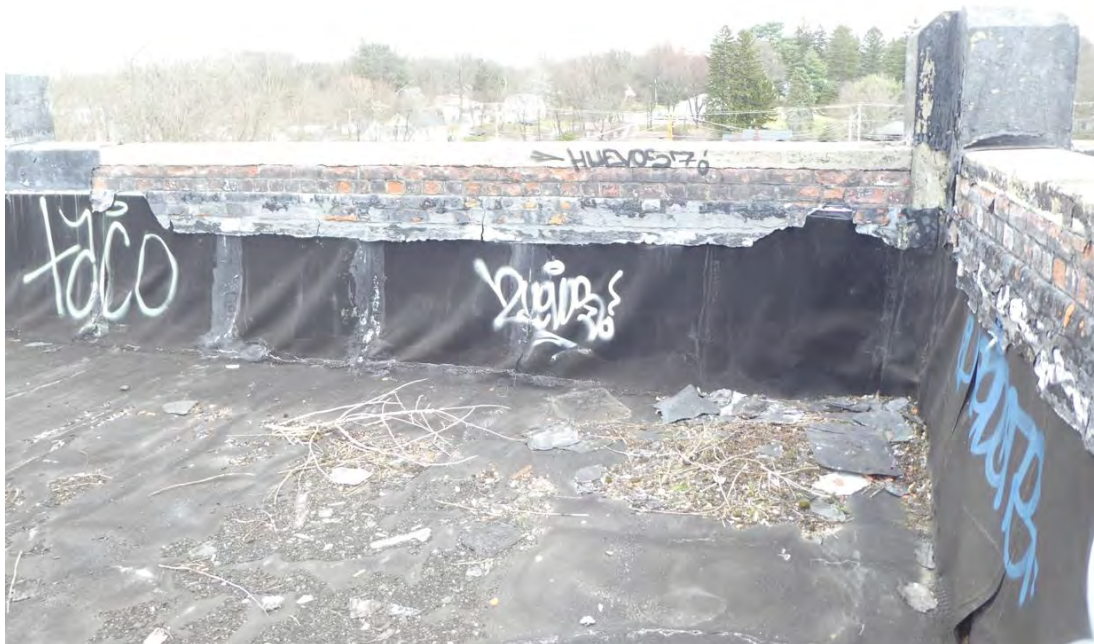
*Photo 31: Building 1, existing membrane roof with open seams and pulled back from existing parapet.*

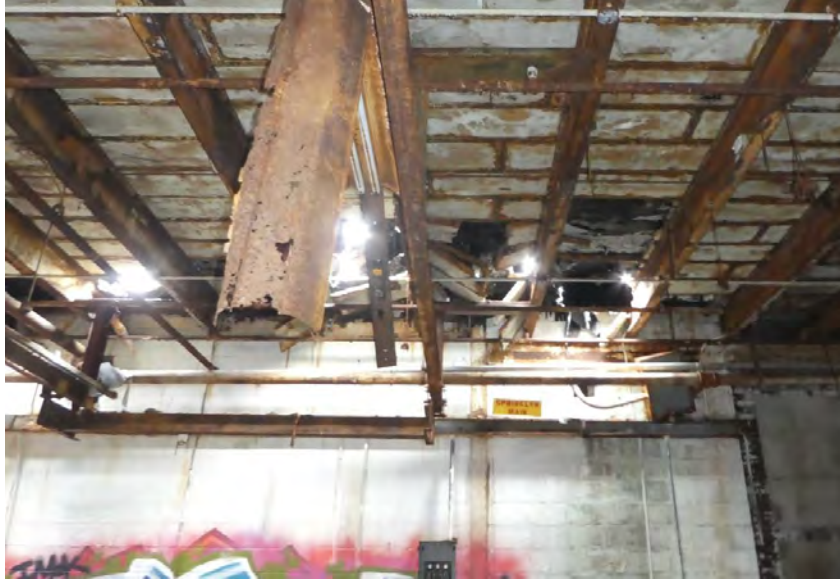
- There are structural roof deck failures along several of the buildings, likely due to moisture infiltration through the failed roofing. The following buildings were observed to have structural roof deck failures:
  - Building 2 (metal edged gypsum plank).
  - Building 3 (metal edged gypsum plank).
  - Building 4 flat roofs and sawtooth valleys (wood tongue-and-groove plank).
  - Building 5 sawtooth valleys and portion of collapsed roof (wood tongue-and-groove plank).
  - Building 6 (poured gypsum deck on steel bulb tees).
  - Building 7 (wood tongue-and-groove plank).
  - Building 8 sawtooth valleys (wood tongue-and-groove plank).
  - Building 21 (metal edged gypsum plank).

*Photo 32: Building 2, gypsum plank deck failure.*

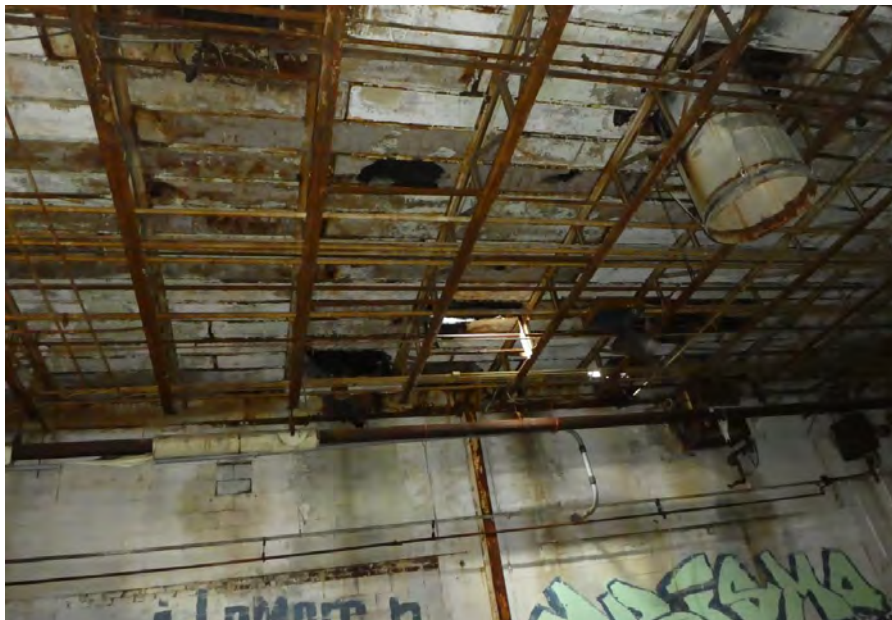
*Photo 33: Building 3, gypsum plank deck failure.*

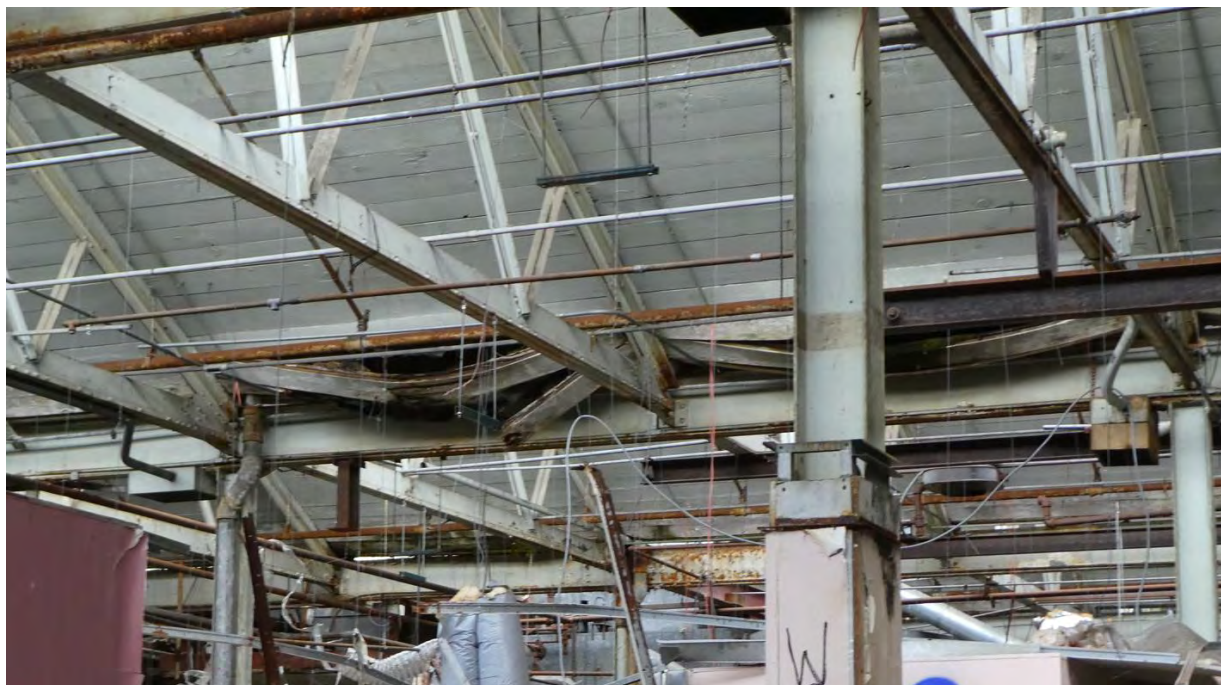
*Photo 34: Building 4, wood plank deck failure.*

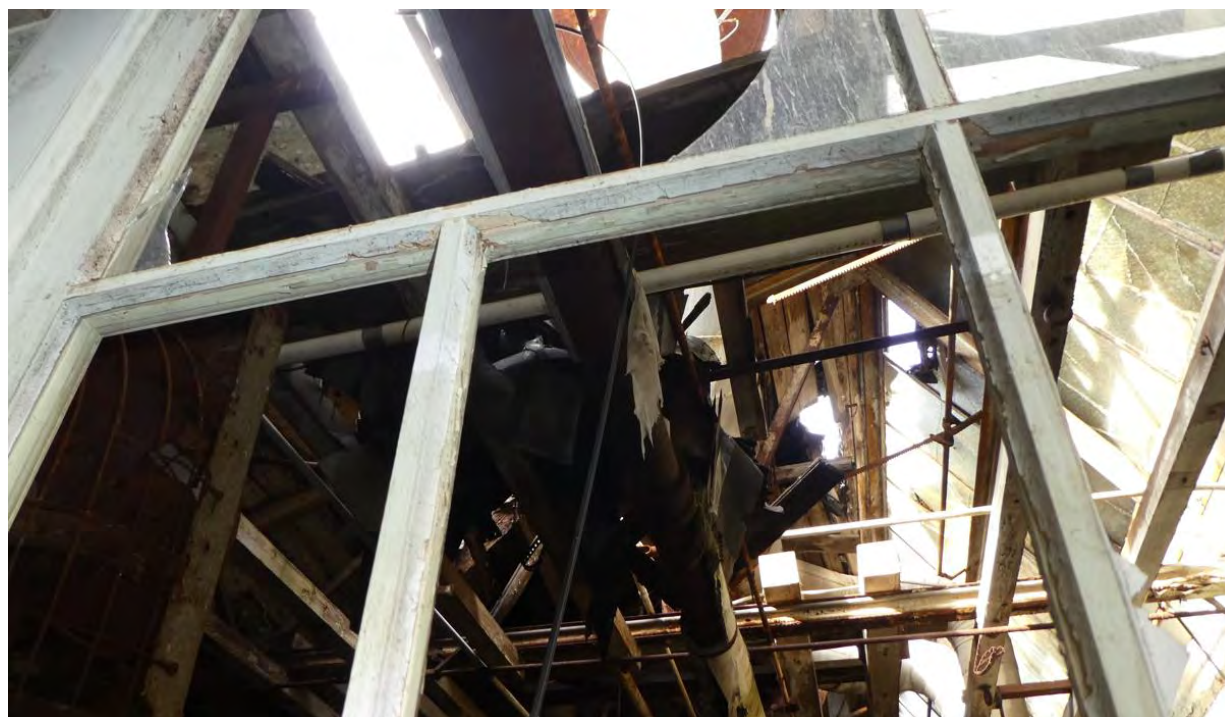
*Photo 35: Building 5, wood plank deck failure.*

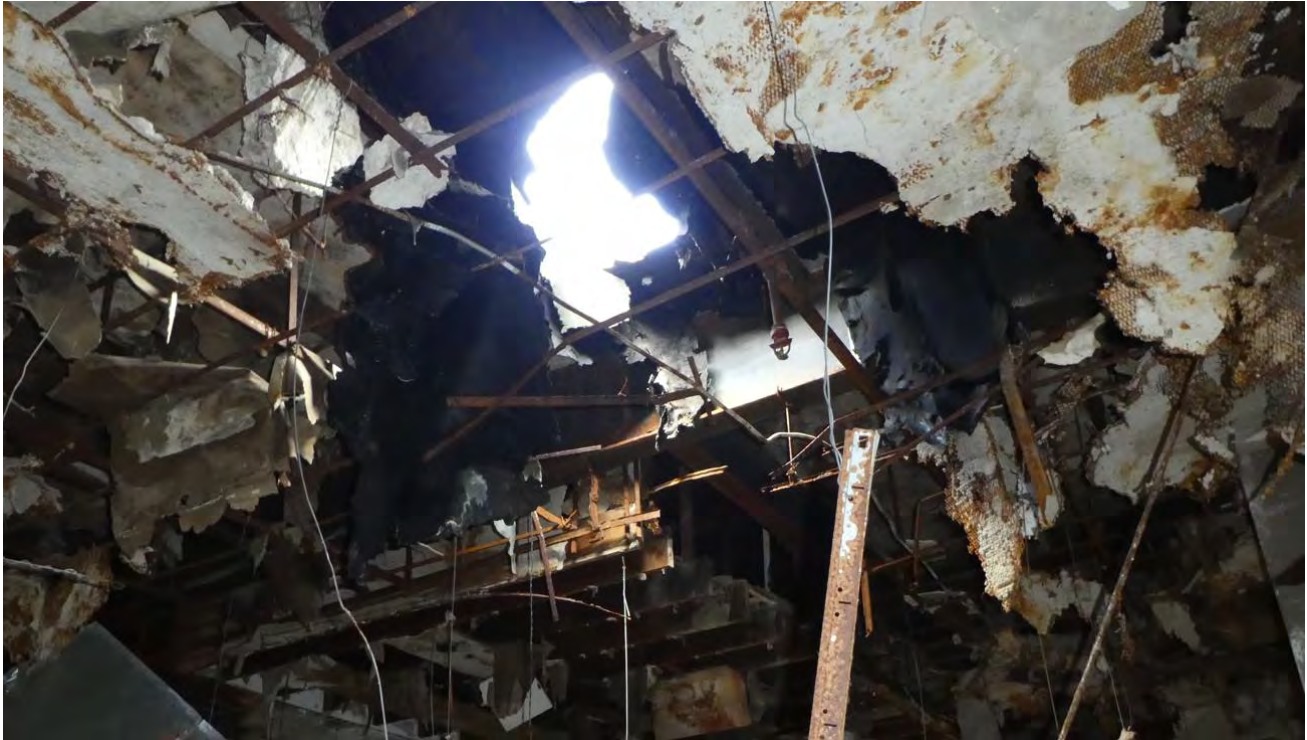
*Photo 36: Building 6, poured gypsum deck failure.*

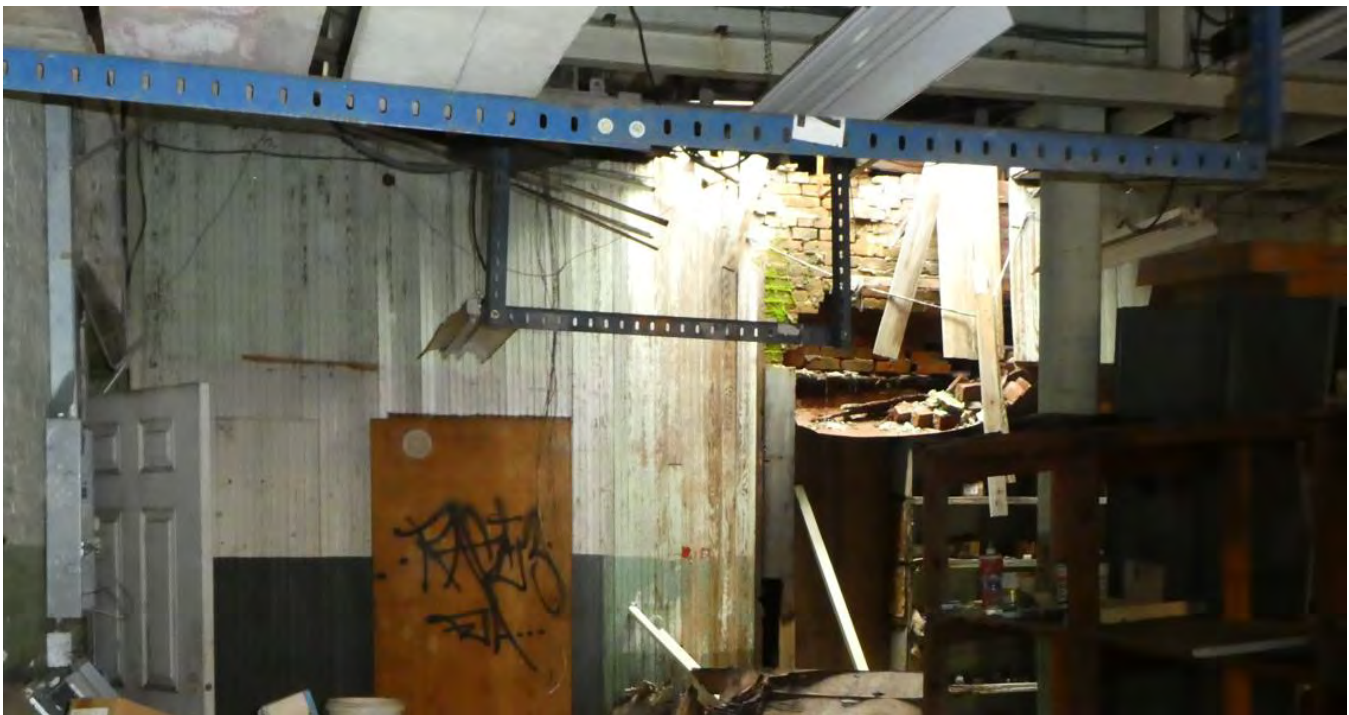
*Photo 37: Building 7, wood plank deck failure.*

- 1.1.2 Building 7 is in unsafe condition due to the failure of the wood framed floor and roof and the extent of masonry deterioration. Building 7 should be demolished.

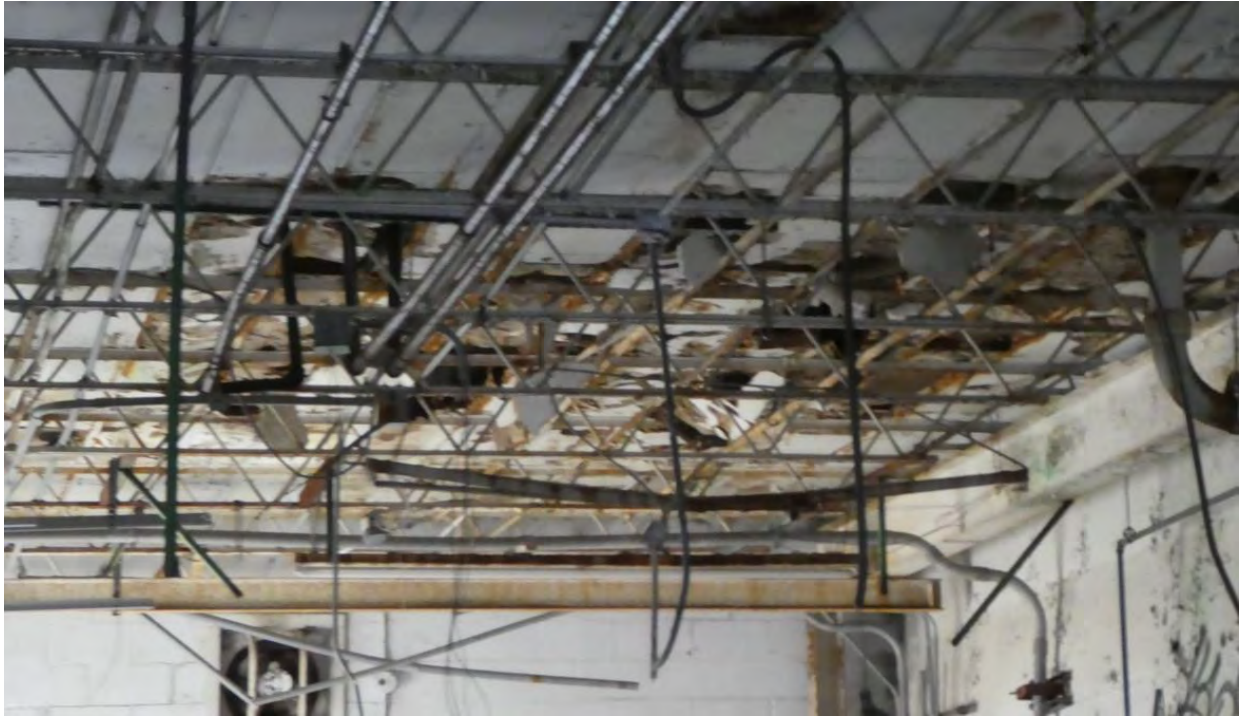
*Photo 38: Building 21, gypsum plank deck failure.*

- 1.2.11 Based on the extent of roof structural deterioration and/or failure, the metal edged gypsum plank roof deck on Building 21 should be removed and replaced as soon as possible to prevent further failure.

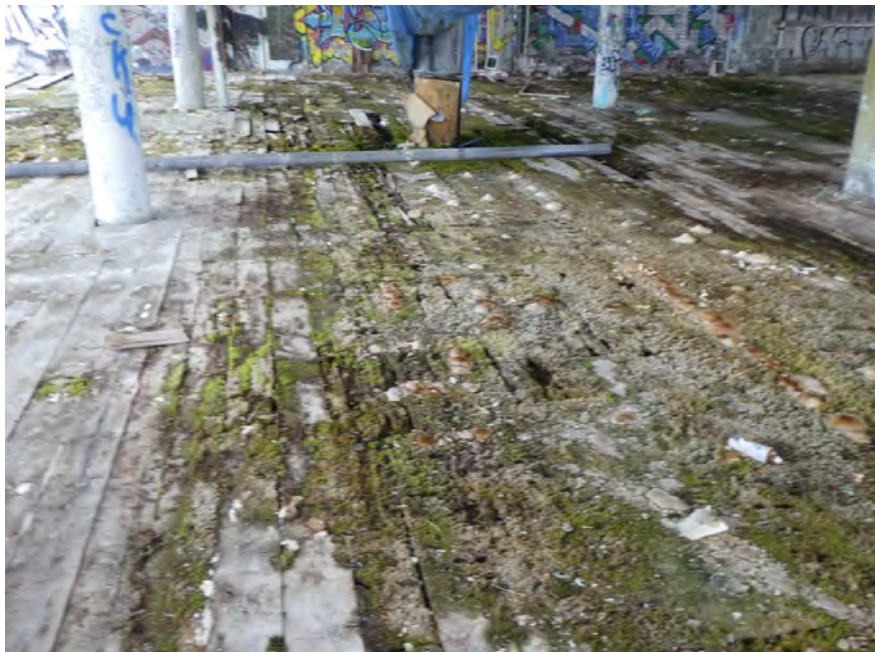
- The buildings consisting of cast-in-place concrete floor slabs and concrete columns contain wood flooring, which is saturated with moisture and organic material, likely from moisture infiltration from the roof (photo 39). This moisture is trapped within the wood flooring and is permeating down into the lower floor levels, which can be seen by the numerous calthemite straw stalactites (photo 40) observed from the ceilings. Additionally, mineral deposits can be seen permeating through the column/slab interface (photo 41).

*Photo 39: Typical concrete deck with wood plank flooring; organic growth.*

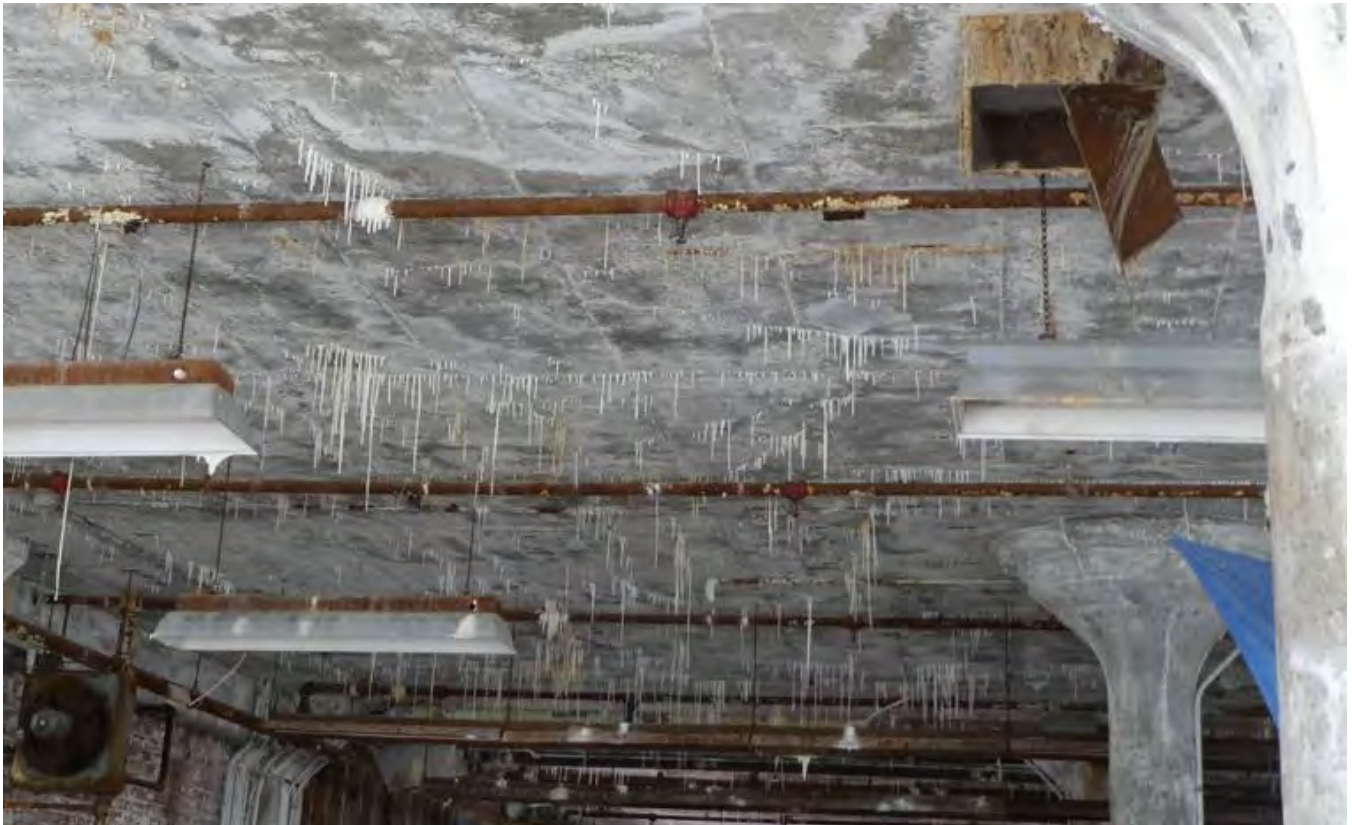
*Photo 40: Typical concrete deck with calthemite straw stalactites along ceilings.*

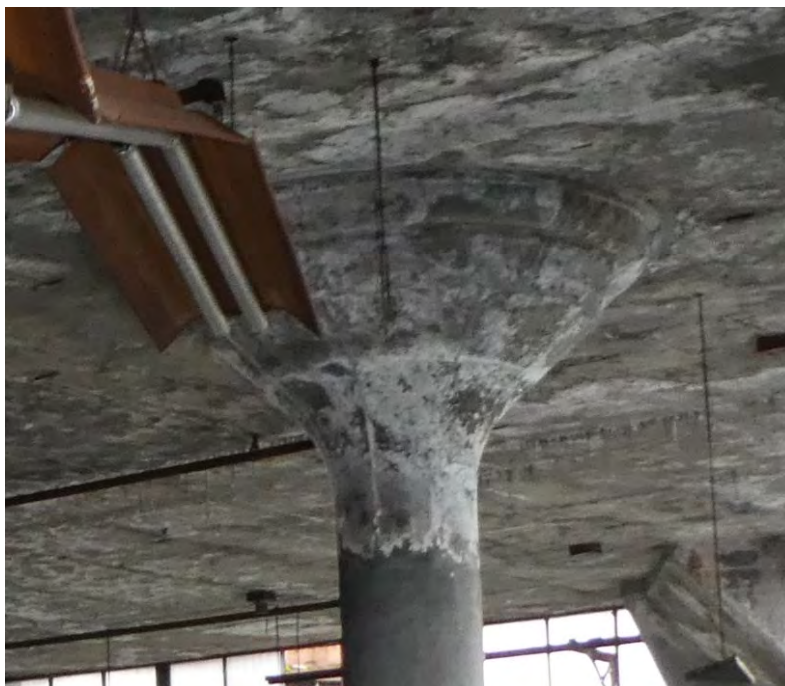
*Photo 41: Typical concrete deck with calthemite straw stalactites along ceilings.*

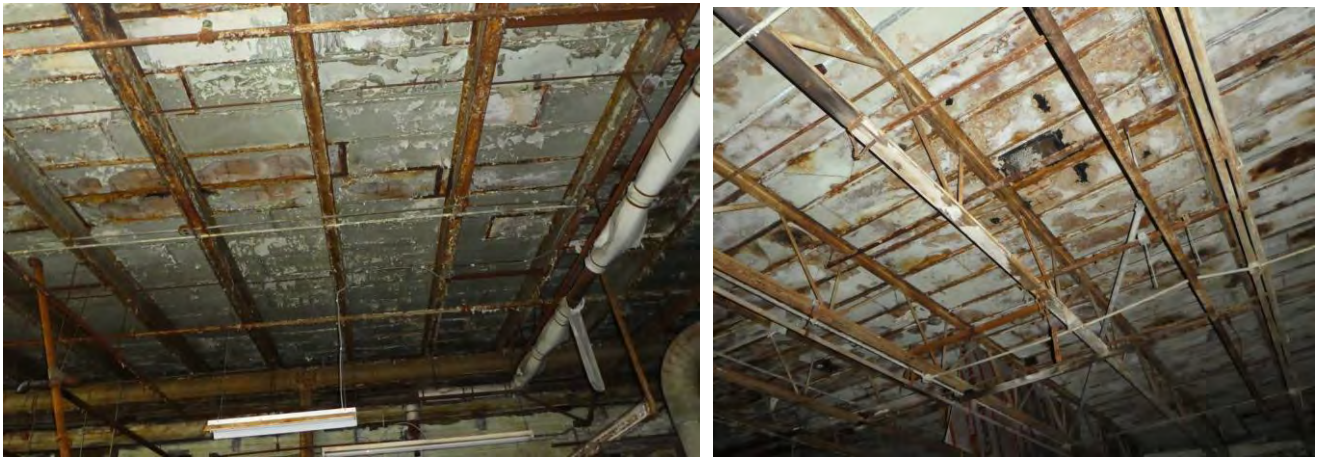
- Structural steel elements (joists, spandrels, girders, columns) supporting the various roofs within the buildings exhibit varying levels of corrosion, likely due to the infiltration of moisture from various points of entry (roof, wall fenestrations, etc.).

*Photo 42 (left): Typical structural steel spandrel beam corrosion (Building 8); Photo 43 (right): Typical open web metal joist corrosion (Building 21).*

1.1.12 Based on the extent of observed steel corrosion, the following building structural steel elements (joists, beams, girders, columns) should be cleaned of rust scale, treated with a corrosion inhibitor and re-painted. Any steel element with more than 15 percent of section loss should be reinforced:

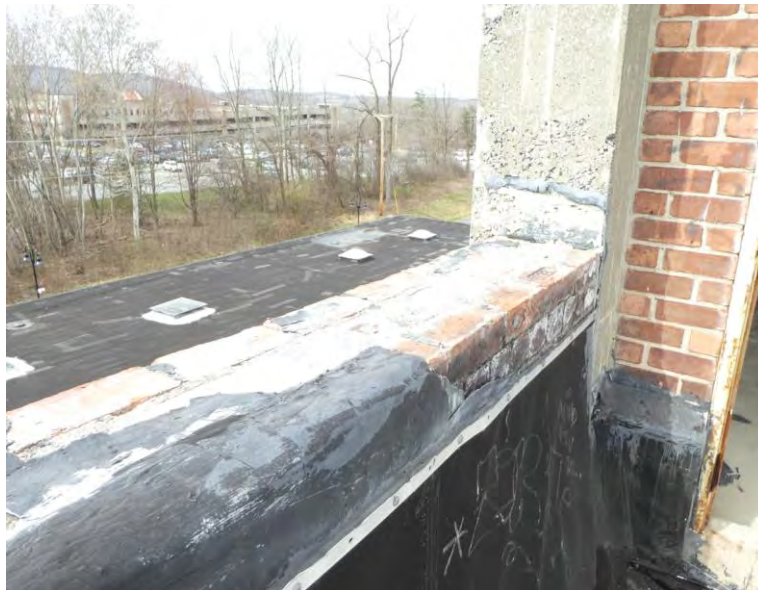
- Along the west side of Building 1, an approximately 10-foot-long section of parapet coping stone has fallen off the roof and onto a lower corrugated roof deck and open web metal joist system. This has caused local failure of both the roof deck and the metal joists. Based on the dimensions and weight of the stone, this was likely caused by human intervention (vandalism). A similar instance was observed at the next adjacent coping stone, which is at risk of falling onto the lower structure.

*Photo 44: Building 1, west wall missing roof parapet coping stone.*

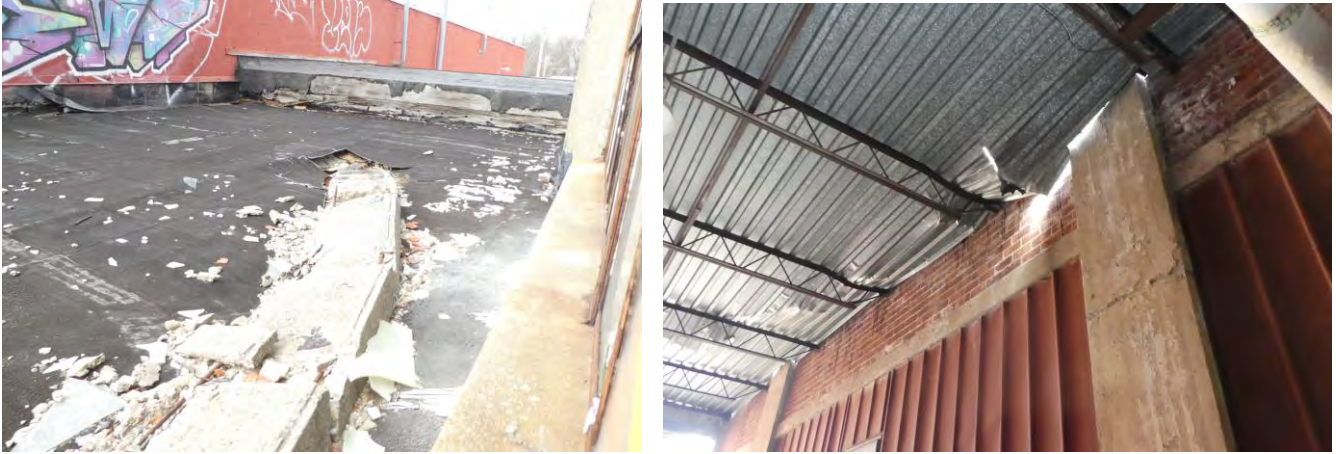
*Photos 45 and 46: Lower roof west of Building 1, images of fallen coping stone and structural damage to roof deck and joists.*

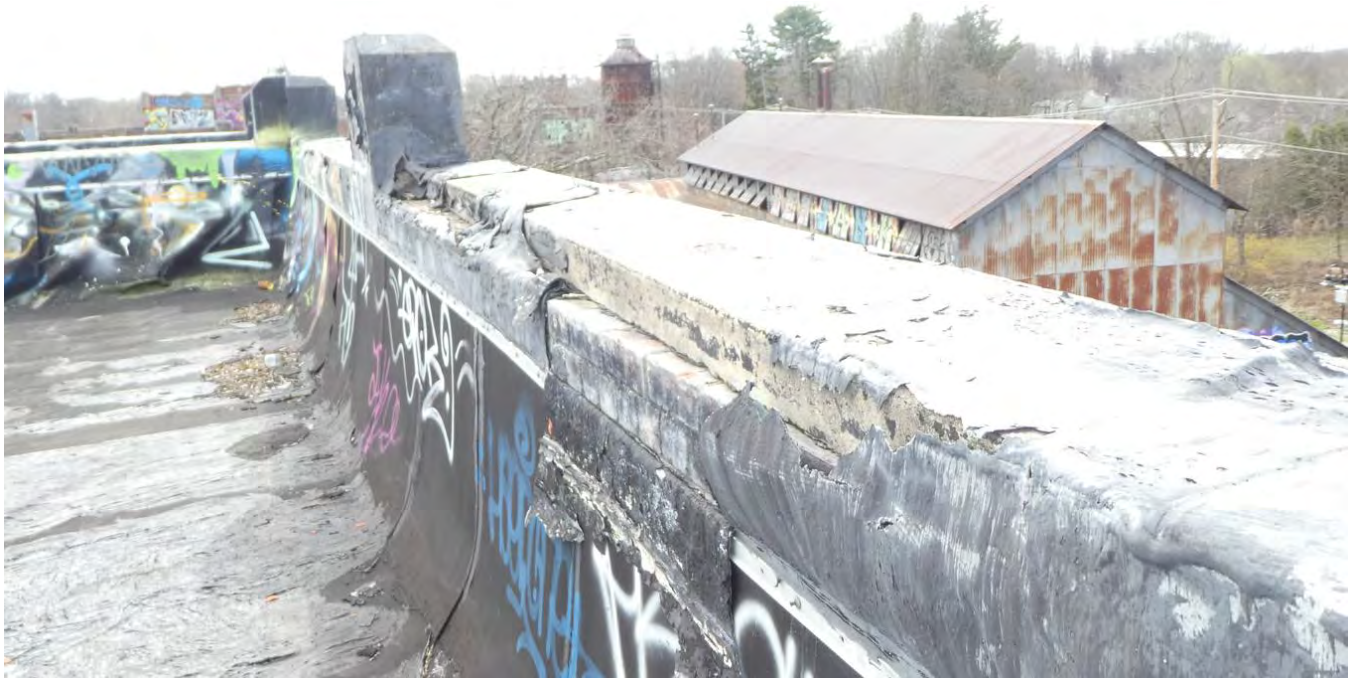
*Photo 47: Building 1, west wall; coping stone at risk of falling onto lower roof.*

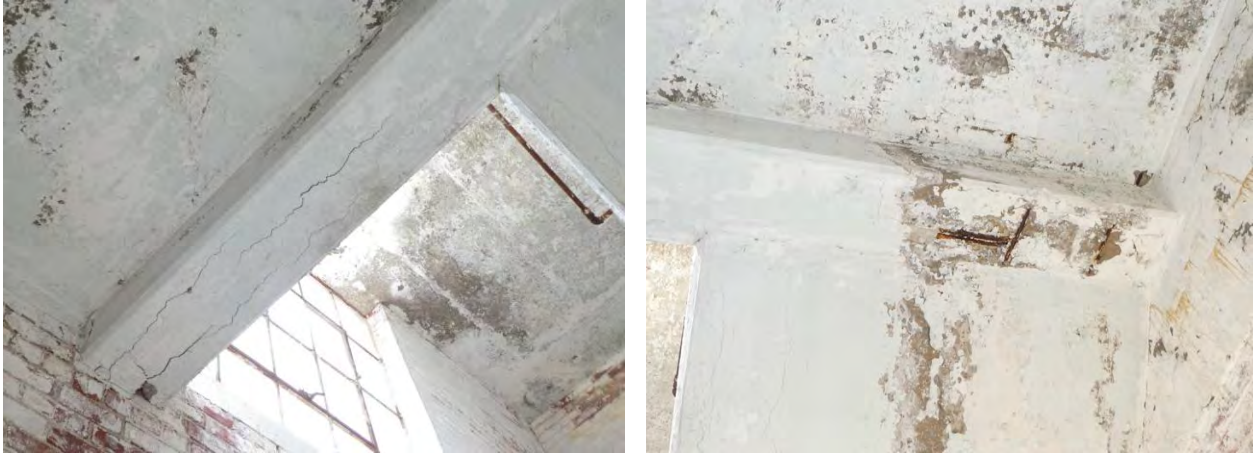
- Within the stair towers at building 1, there is cracking of concrete landing beams and exposed, corroded reinforcing bar at the third floor.

*Photos 48 and 49: cracked 3<sup>rd</sup> floor landing beam and exposed, corroded reinforcing bar.*

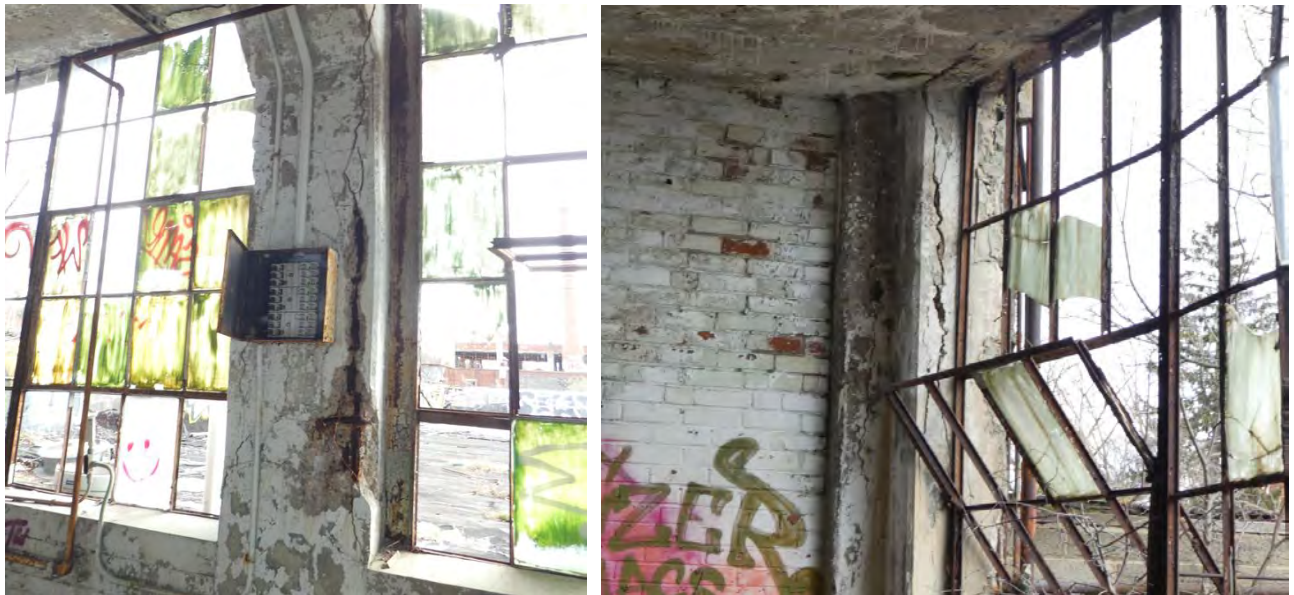
- On the second floor of Building 1, several exterior concrete columns have exposed reinforcing bar and large vertical and diagonal cracks indicative of spalling caused by the corrosion of steel reinforcing.

*Photos 50 and 51: Building 1, cracks and exposed reinforcing in exterior concrete columns.*

1.1.10 The concrete columns at Building 1 have condition varying in poor to good condition. Any columns that have crack widths exceeding 1/16 inches should be sounded to determine if the concrete has delaminated from the column. Concrete in the delaminated areas should be removed and re-poured. While this is occurring, the rebar in the cracked areas should also be inspected for rust and rust should be removed prior to pouring patching concrete. Any rebar that has lost more than 15% of its section should be removed and a new bar should be spliced to the existing.

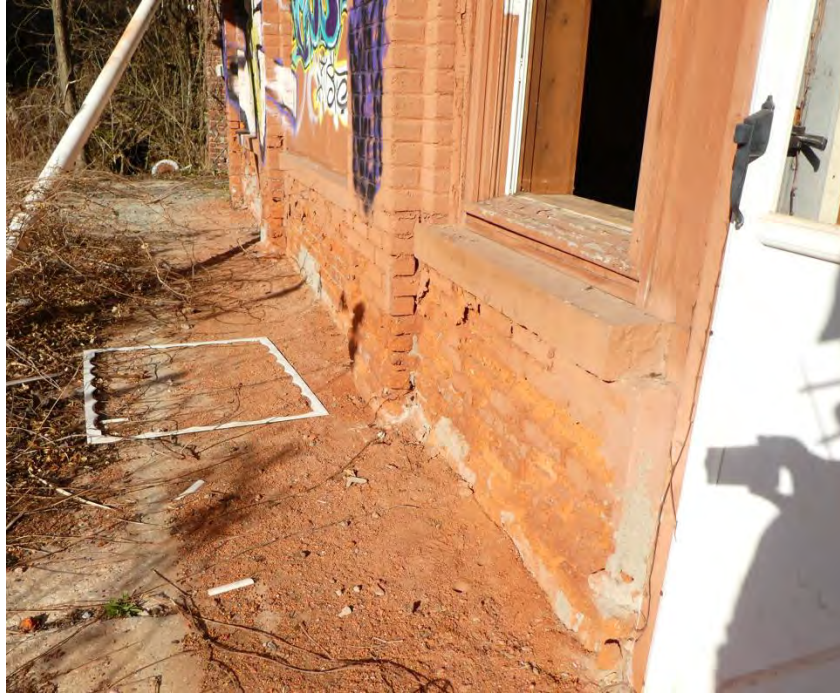
- Along Building 7, the lower two feet of brick masonry wall is deteriorated, with brick fragments and dust deposited along the ground of the building.

*Photo 52: Building 7, brick fragments and deterioration along base of wall.*

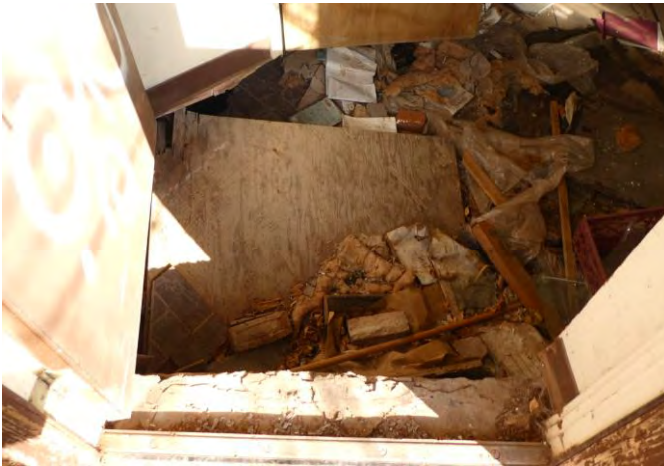
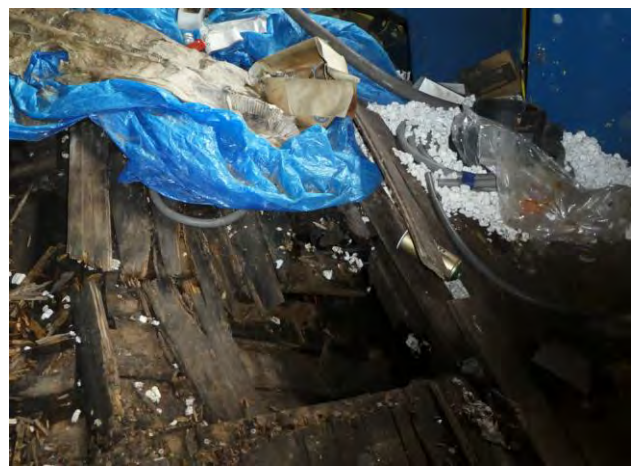
- At Building 7, the first floor and framing has collapsed in several areas, impeding entry into the building.

*Photos 53 and 54: Building 7, images of floor collapse.*

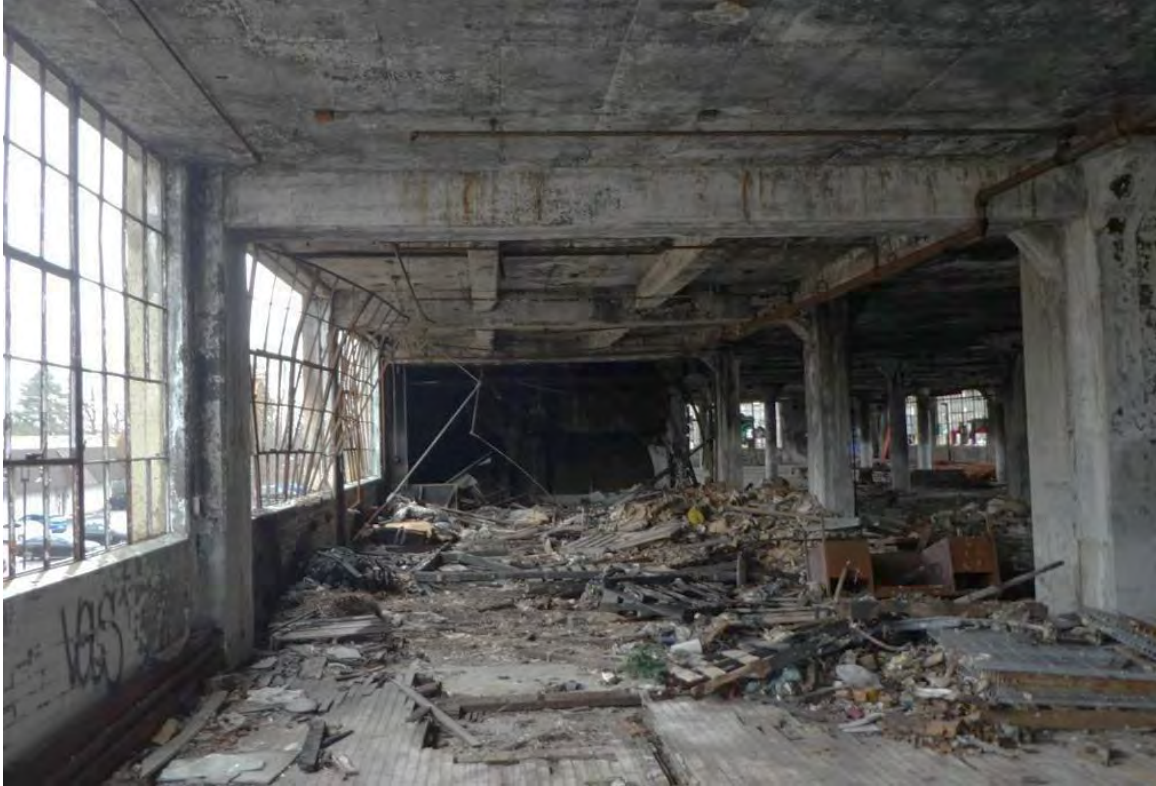
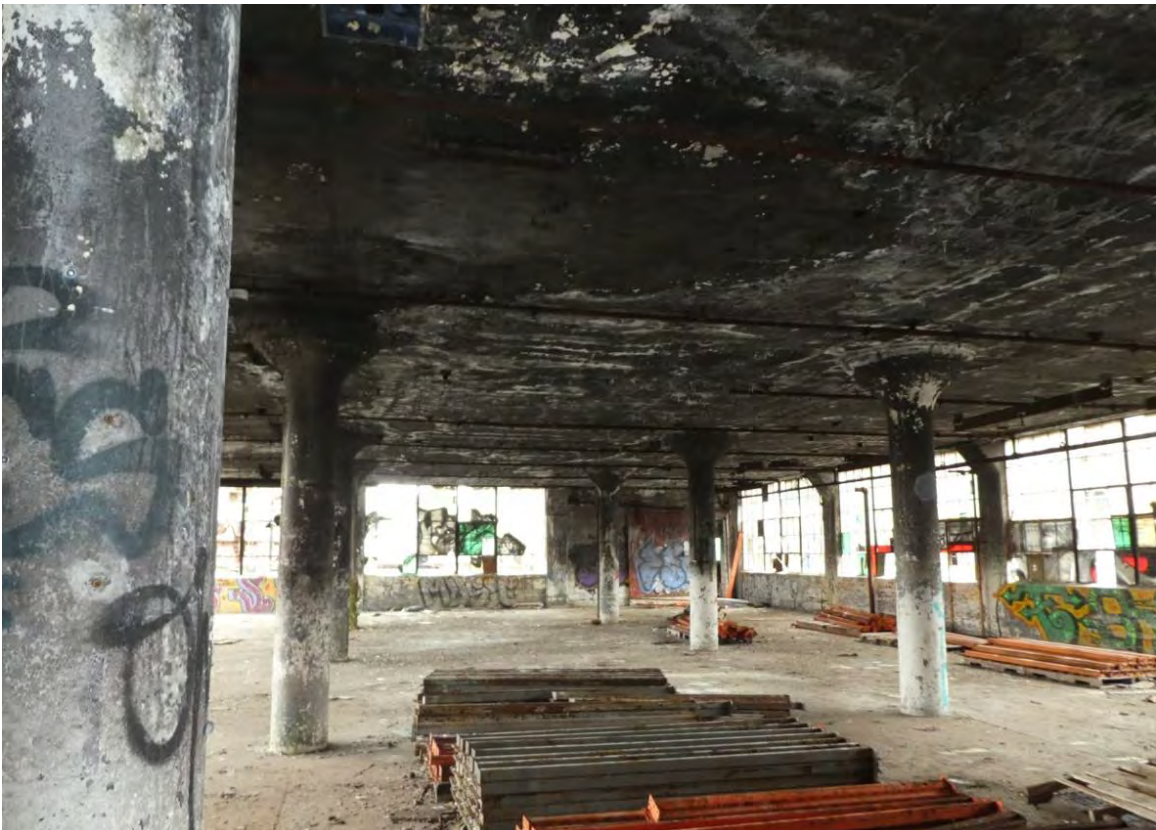
- Soot and smoke staining on concrete structural elements (slab, beams, columns) were observed on the third floor of Building 10 and on the second floor of Buildings 12 through 14. Additionally, burnt debris was observed throughout the area. Concrete beams and slab components exhibit varying degrees of cracking and spalling, specifically along building 14 concrete beams (see photo 55).

*Photos 55 (above): Building 14 second floor, staining from fire damage (looking north) and Photo 56 (below): Building 12 second floor, staining from fire damage (looking north).*
