# Structural Condition Assessment

## Former Schatz Manufacturing Co. Building Campus

Fairview Avenue, Poughkeepsie NY

Date: June 28th, 2024

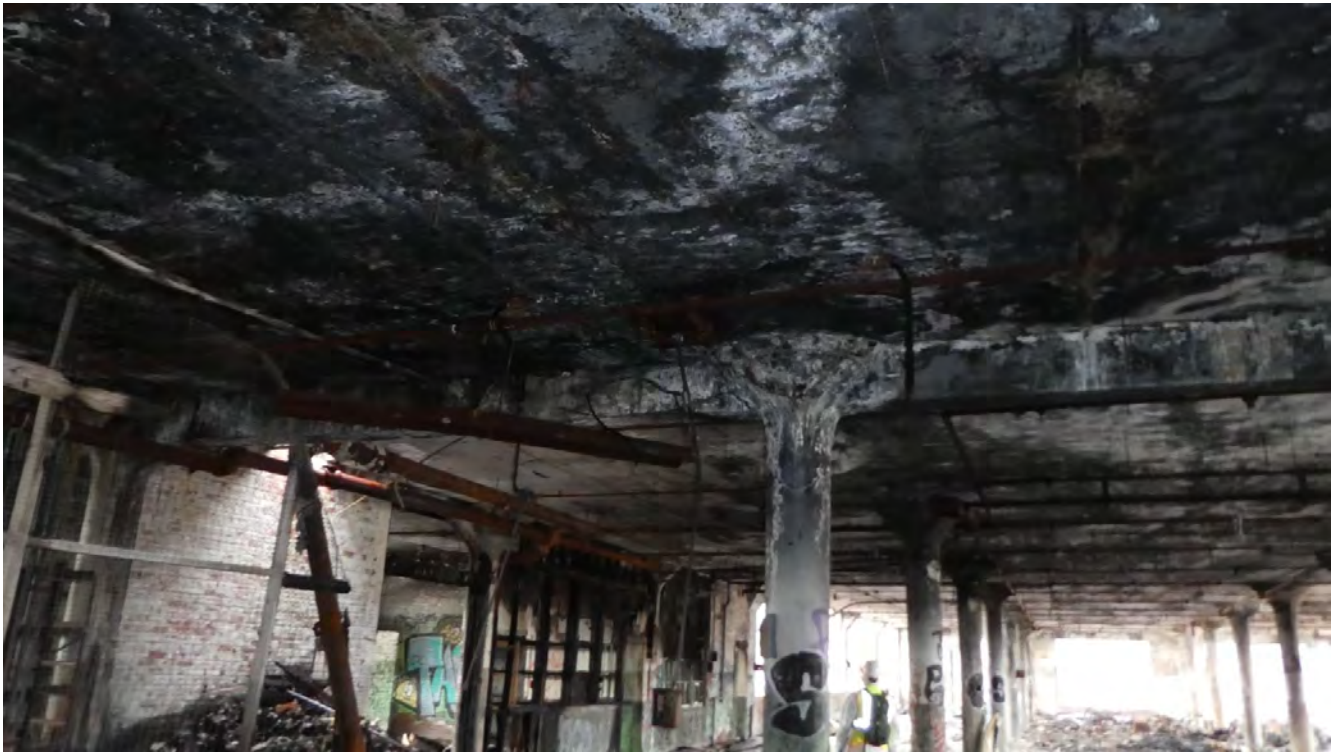
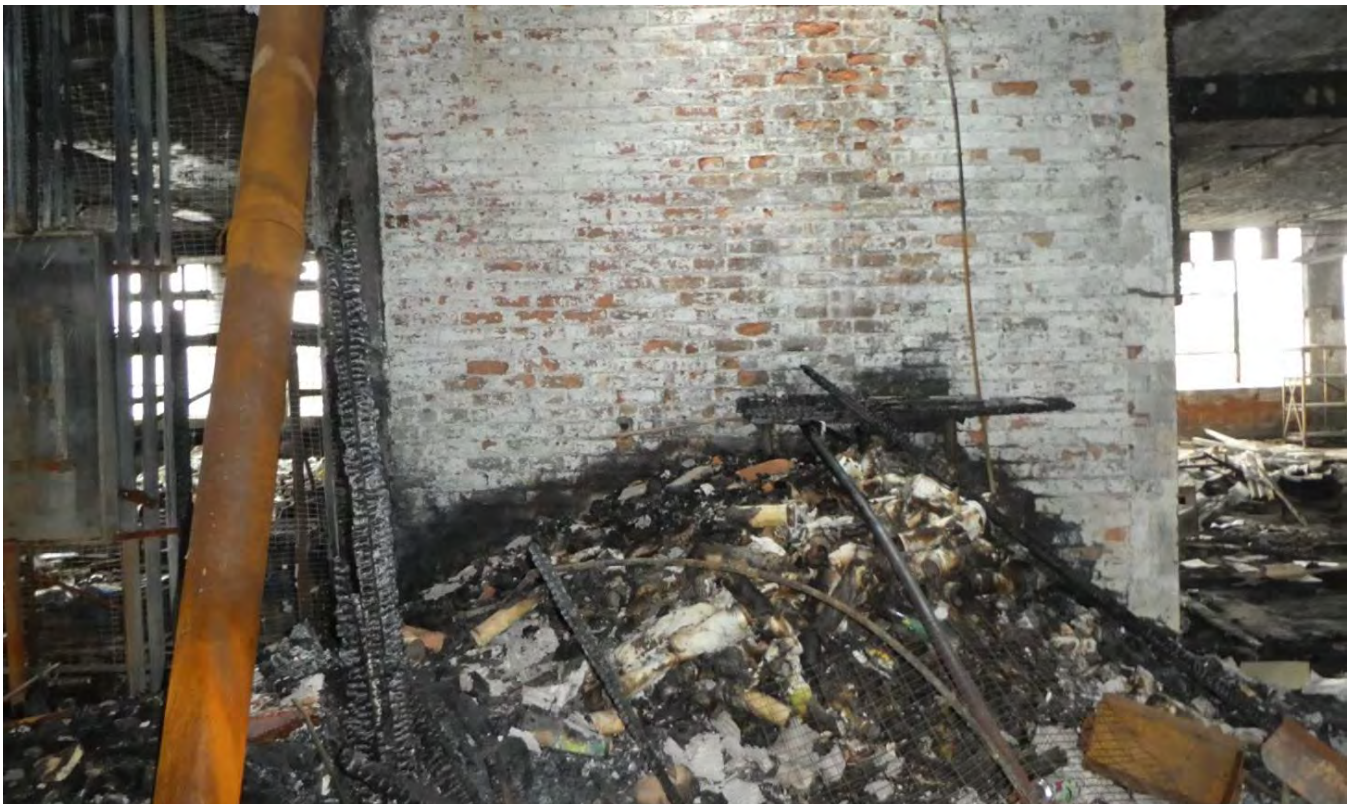
*Photos 57 (above): Building 10 third floor, staining from fire damage (looking northeast) and Photo 58 (below): Building 10 third floor, building debris from fire at freight elevator (looking north).*

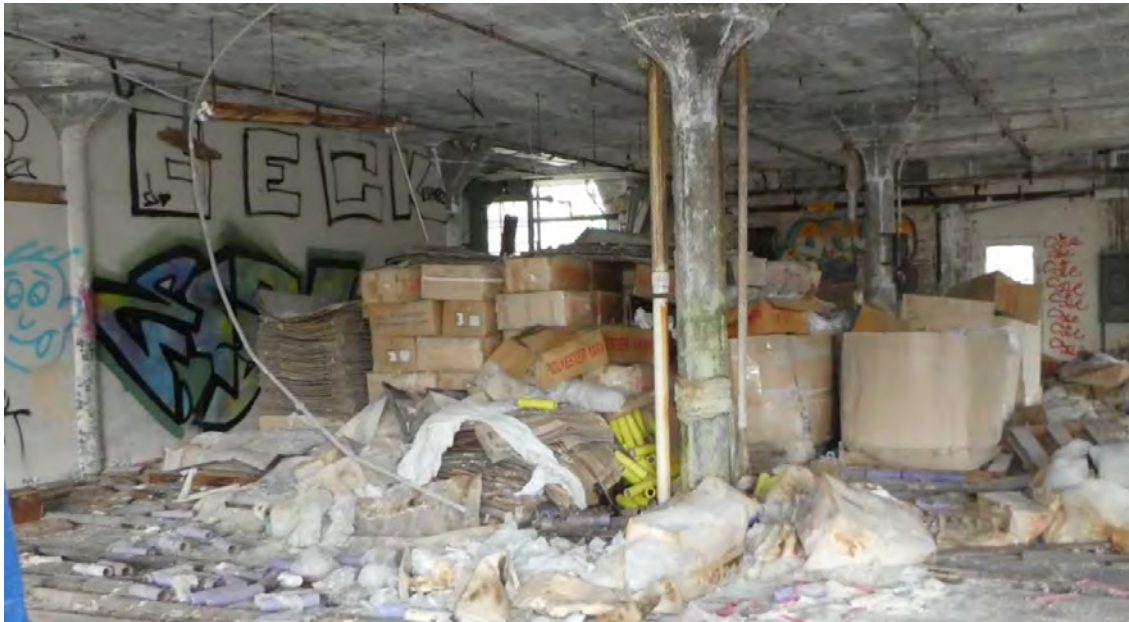
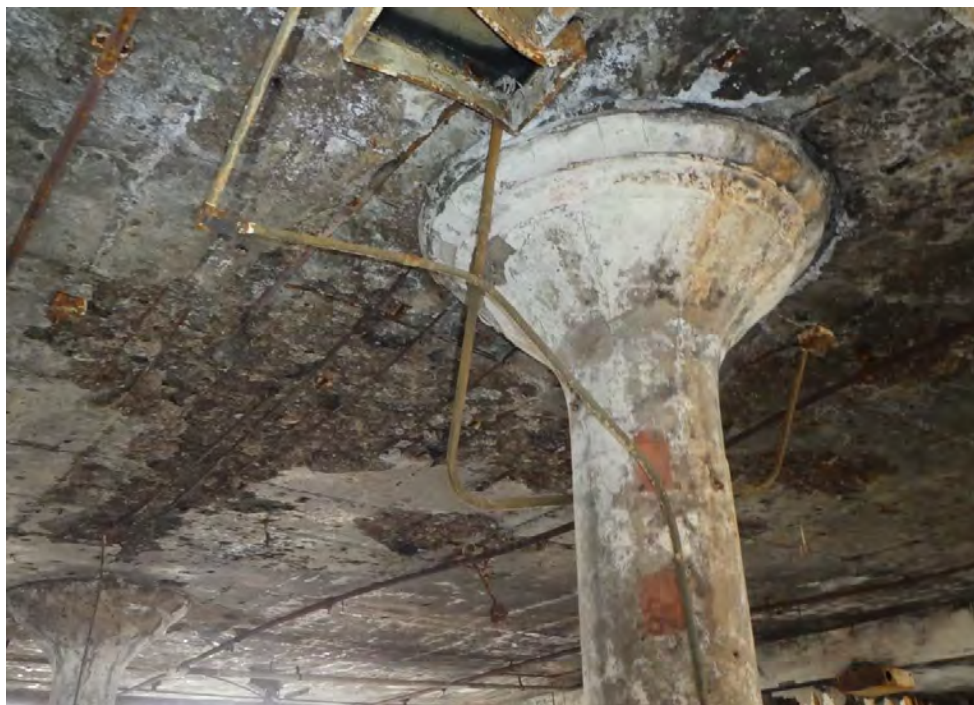
- Stored materials, such as storage rack components, textiles, and other raw materials are stored in various areas of the building leading to impassible conditions. On the third floor of Building 12, the concentrated storage of materials is causing floor sagging and spalling of the concrete, as observed from the ceiling of the second floor.

*Photos 59 (above): Building 12 third floor, concentrated stored materials (looking southwest) and Photo 60 (below): Building 12 second floor looking at third floor bottom of slab, spalling, exposed rebar and sagging of slab under stored materials (looking southeast).*

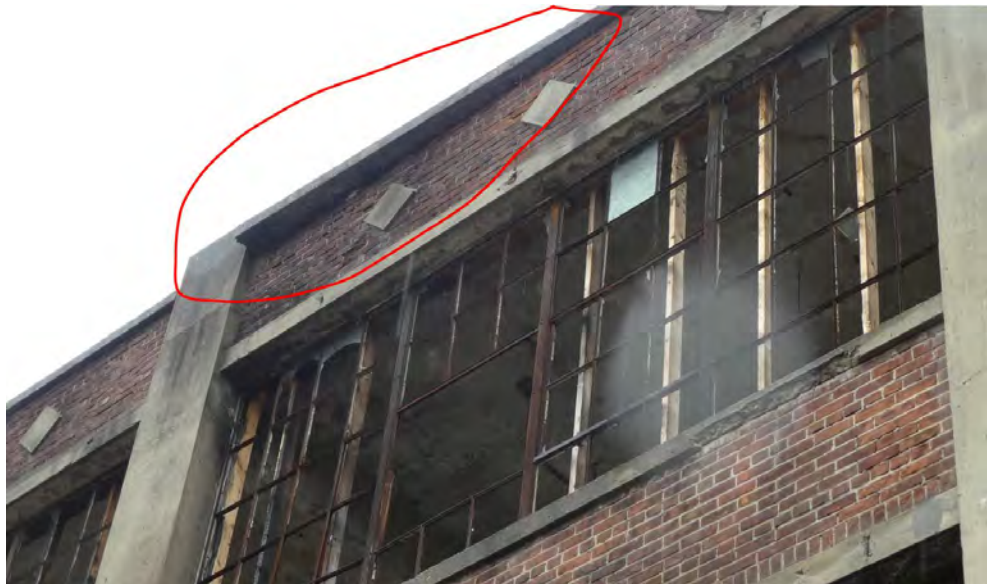
*Photo 62: Building 14 parapet coping stone loose.*

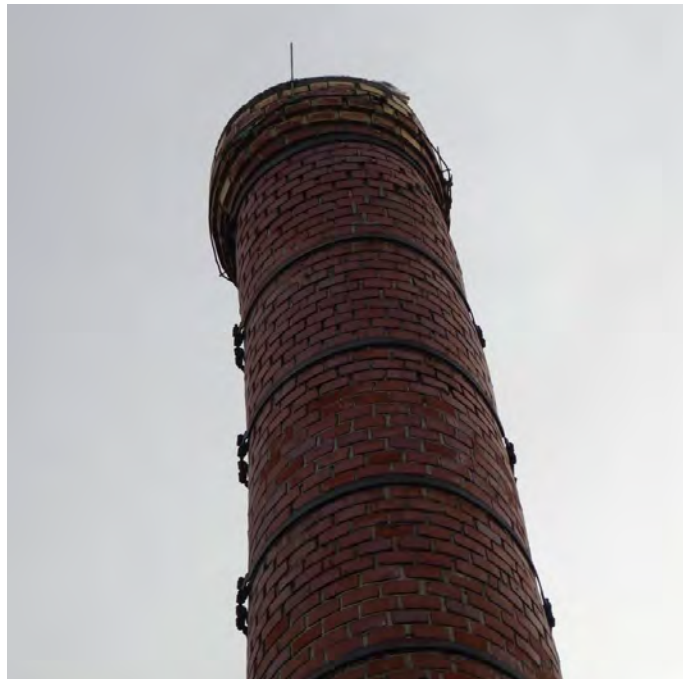
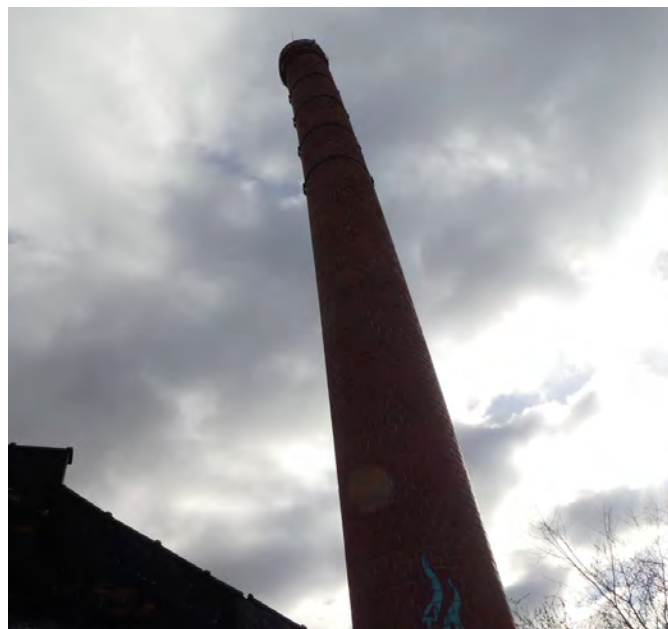
*Photos 63 and 64: 74-foot-tall Boiler stack*

- 1.3.1 The 74-foot-tall brick boiler flue stack is leaning to the north approximately 0.72 degrees, or approximately 11.25 inches. Additionally, the head and bed joints along the upper third of the stack are severely deteriorated, and vertical cracking and bulging of masonry may be an indication of failure due to hoop stresses. Based on these considerations, the 74-foot-tall brick boiler stack is in unsafe condition and should be demolished.
- 1.3.2 The 98-foot-tall brick boiler flue stack is leaning to the north approximately 0.43 degrees, or approximately 8.75 inches. Additionally, the head and bed joints along the upper third of the stack are severely deteriorated, and vertical cracking may be an indication of failure due to hoop stresses. Based on these considerations, the 98-foot-tall brick boiler stack is in unsafe condition and should be demolished.
