# Structural Condition Assessment

## Former Schatz Manufacturing Co. Building Campus

Fairview Avenue, Poughkeepsie NY

Date: June 28th, 2024

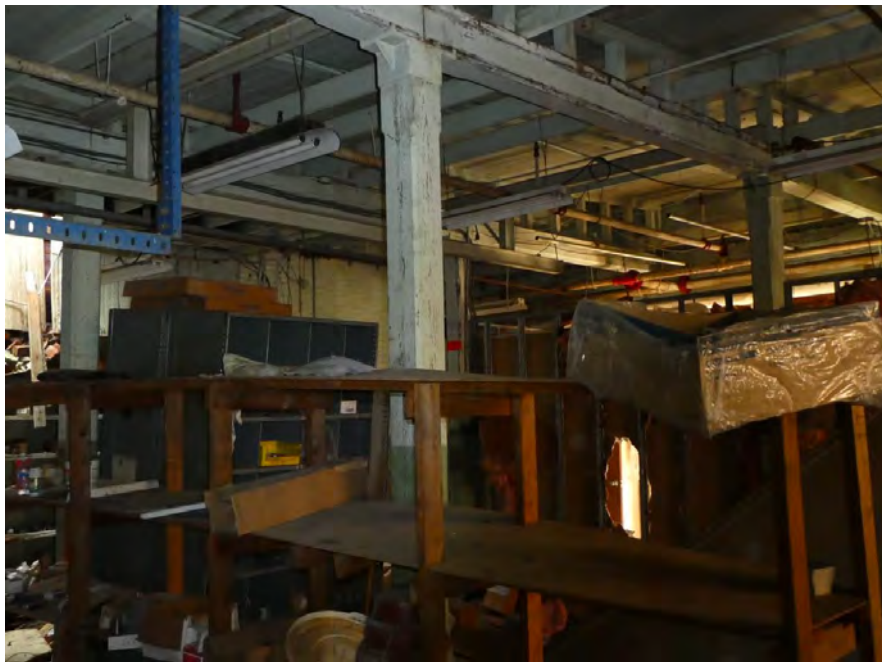
Building 7 is a 3,000 square foot, single story structure. The roof consists of tongue and groove wood planks spanning between wood cripple wall beam supports spaced at approximately 10 feet on center. These cripple walls are supported by heavy timber beams, which bear on heavy timber columns and on unreinforced brick bearing walls. The floor appears to be a wood floor with wood lumber joists, but due to the level of debris and collapsed floor structure it could not be confirmed.

*Photo 7: Building 7, looking southeast.*

- 1.1.2 Building 7 is in unsafe condition due to the failure of the wood framed floor and roof and the extent of masonry deterioration. Building 7 should be demolished.

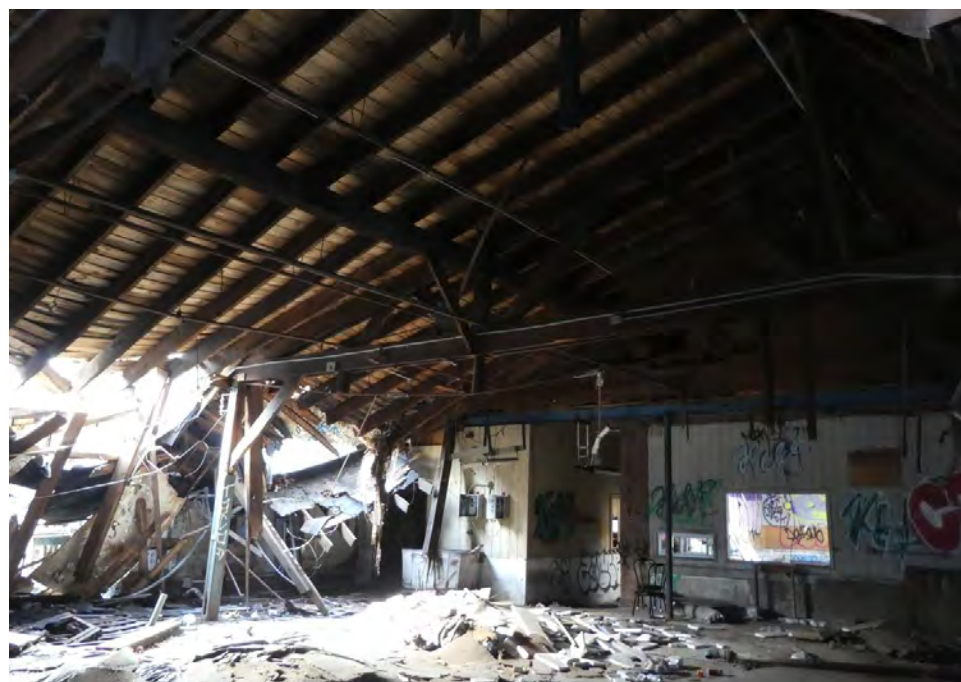
*Photo 16: Partially collapsed timber building, looking southwest from building 18.*

- 1.2.1 Building 18 is in unsafe condition due its roof structure being physically connected to the existing timber framed building south of it that is currently collapsing. Building 18, as well as the timber framed building should be demolished.

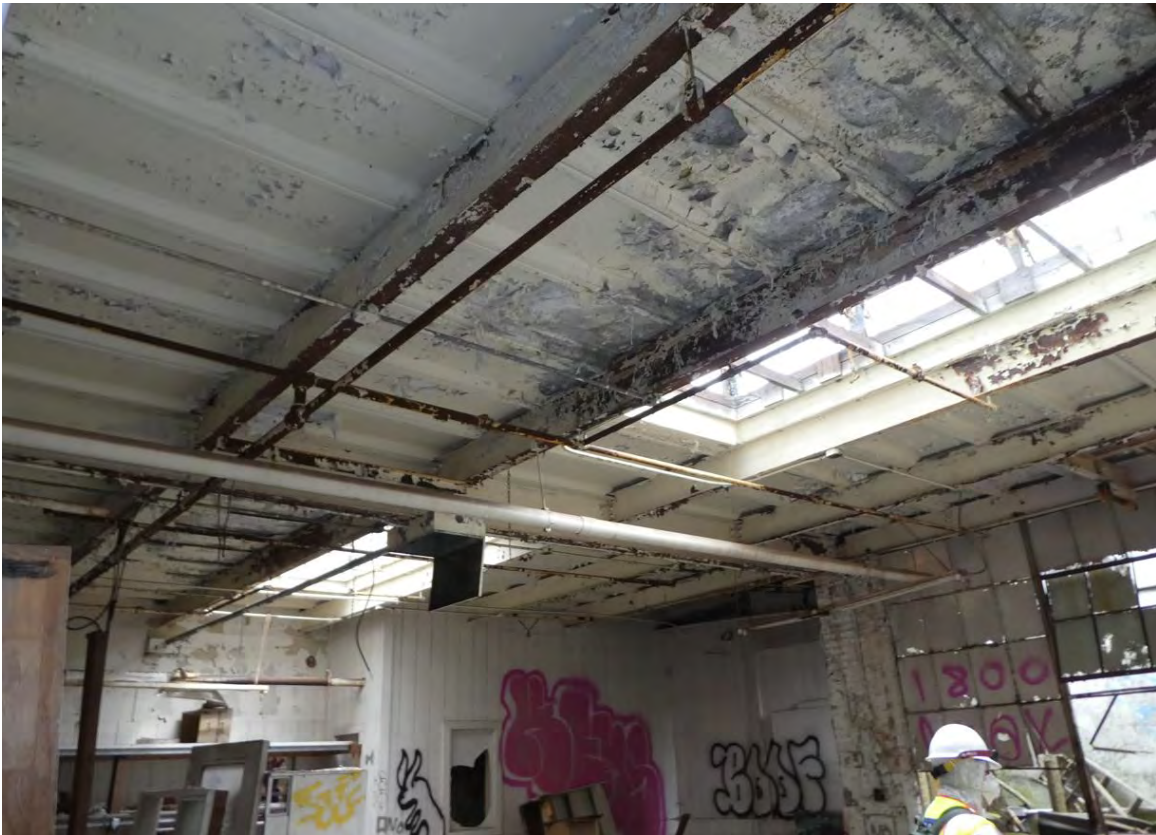
*Photo 17: Building 19 roof and skylights, looking northeast.*

- 1.2.2 Building 19 is in unsafe condition due to the level of deterioration of the concrete channel plank roof, the condition of the structural steel elements, and the failure of the window lintel on the south face of the building. Building 19 should be demolished.

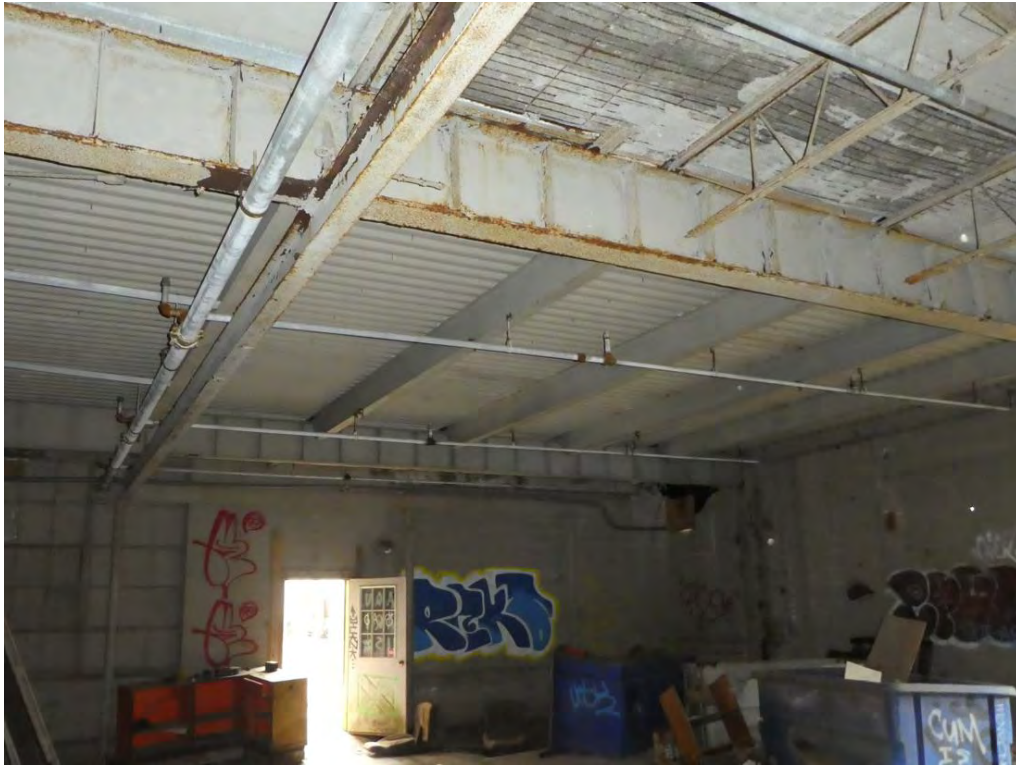
*Photo 18: Building 20 roof deck transition, looking northeast.*

- 1.2.3 Building 20 is in unsafe condition due to the failure of the concrete plank roof as well as structural failure of at least four roof joists. Building 20 should be demolished.

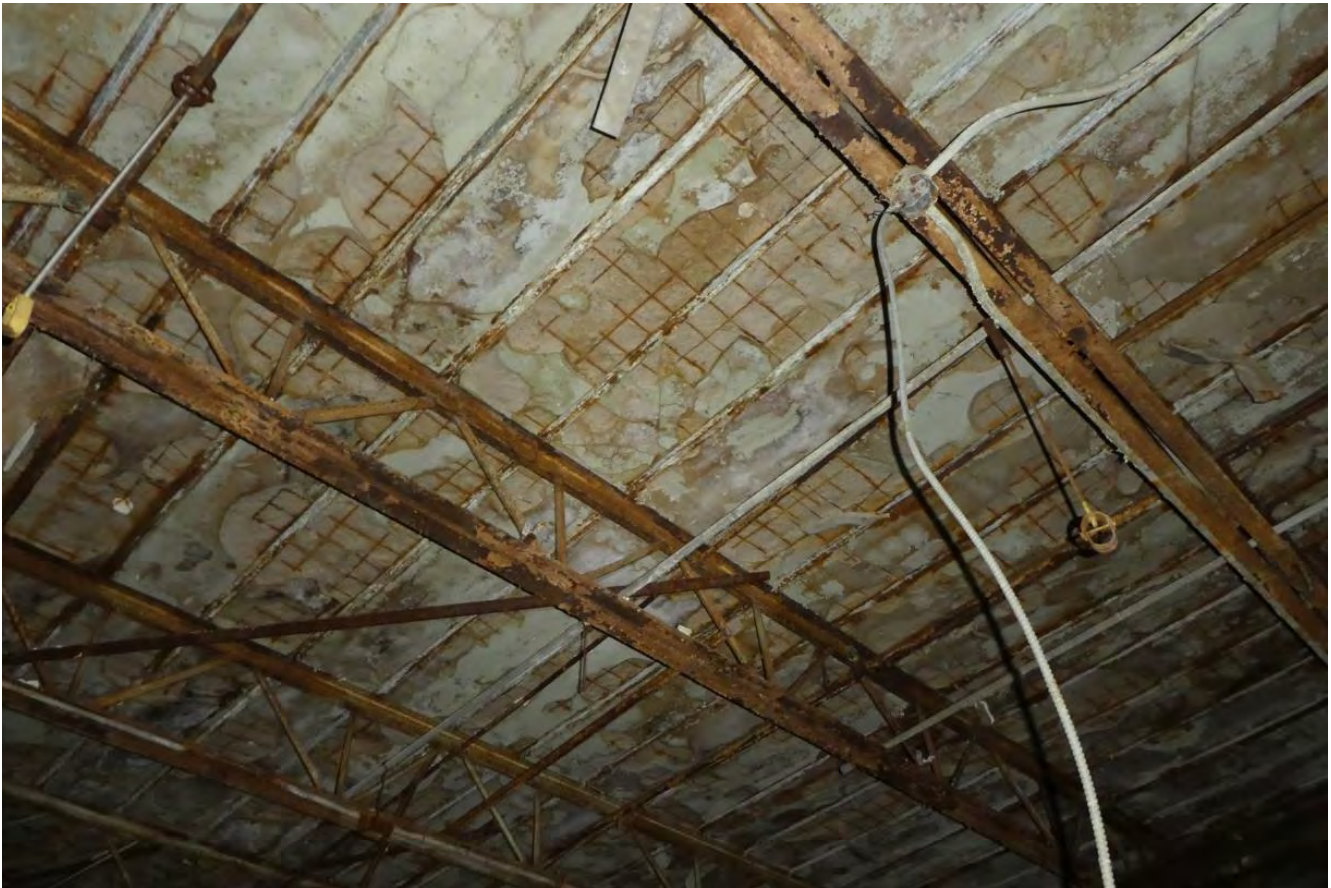
*Photo 20: Building 21 roof, looking northwest.*

- 1.2.11 Based on the extent of roof structural deterioration and/or failure, the metal edged gypsum plank roof deck on Building 21 should be removed and replaced as soon as possible to prevent further failure.

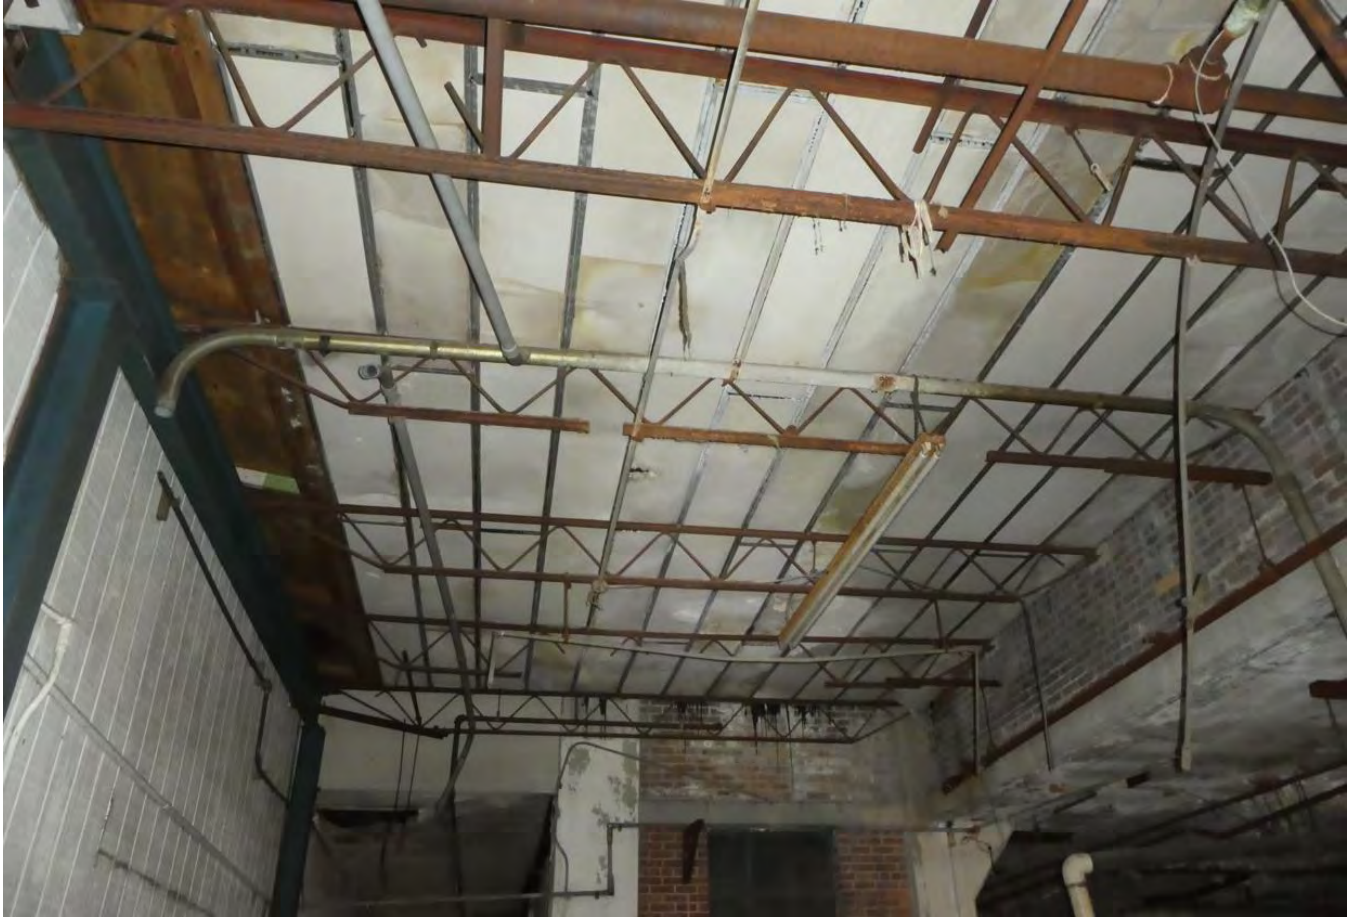
*Photo 21: Building 22 roof, looking west.*

- 1.2.5 Building 22 is in unsafe condition due to the failure of at least three roof joists and its proximity to the existing timber framed building south of it that is currently collapsing. Building 22, as well as the timber framed building should be demolished.

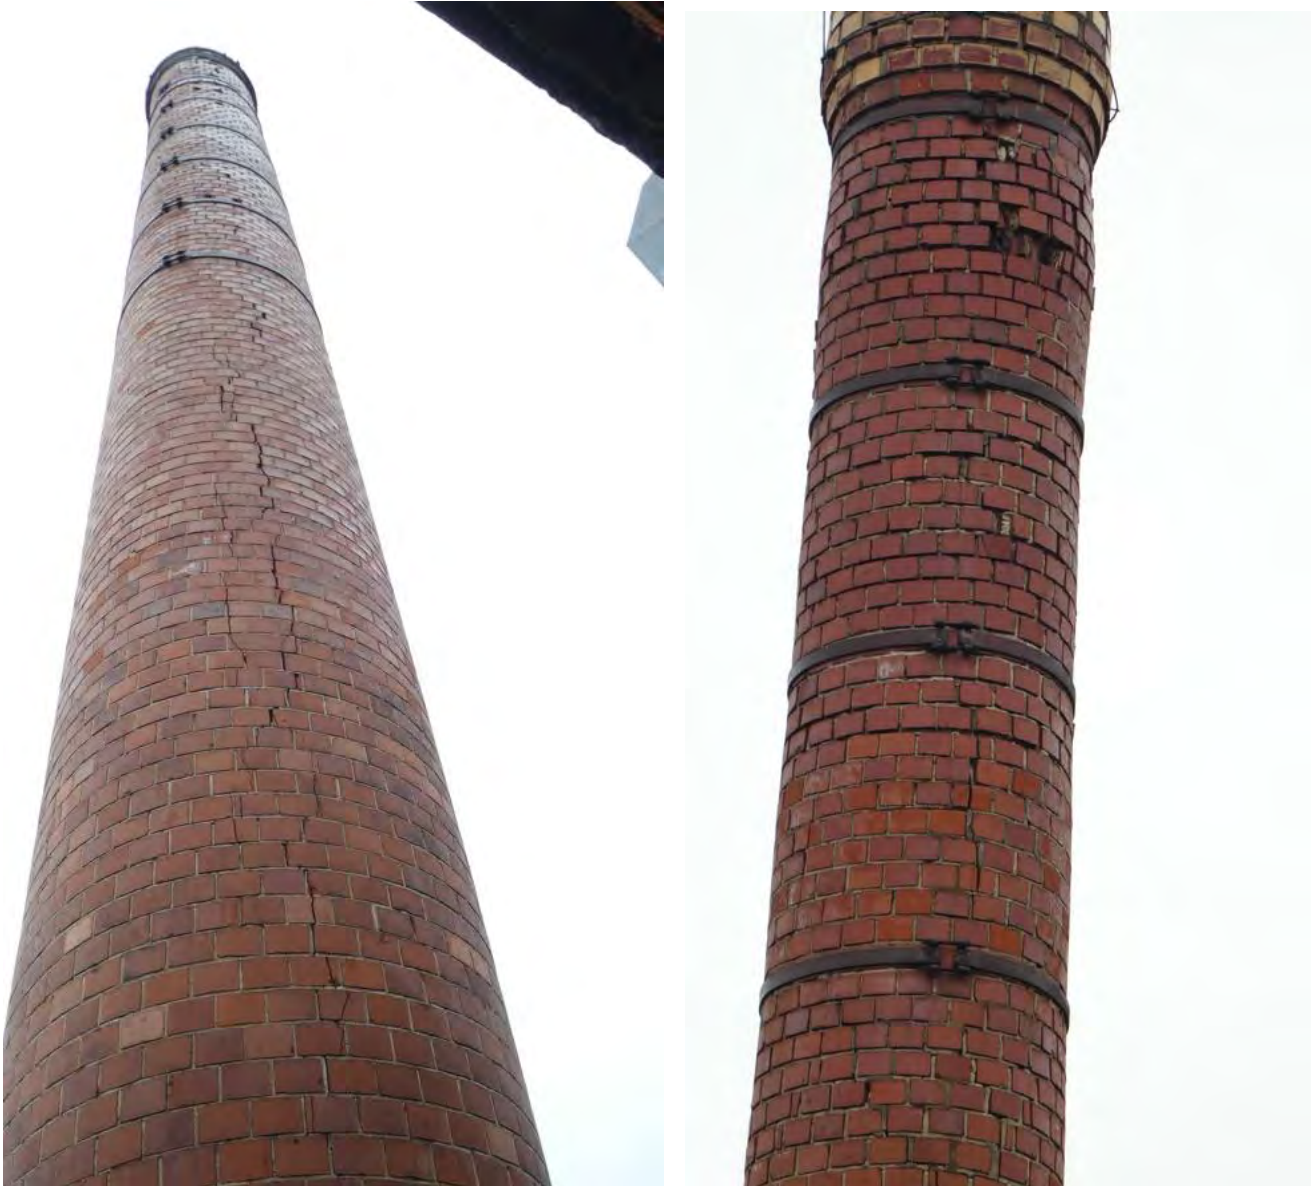
*Photos 65 and 66: 98-foot-tall Boiler stack*

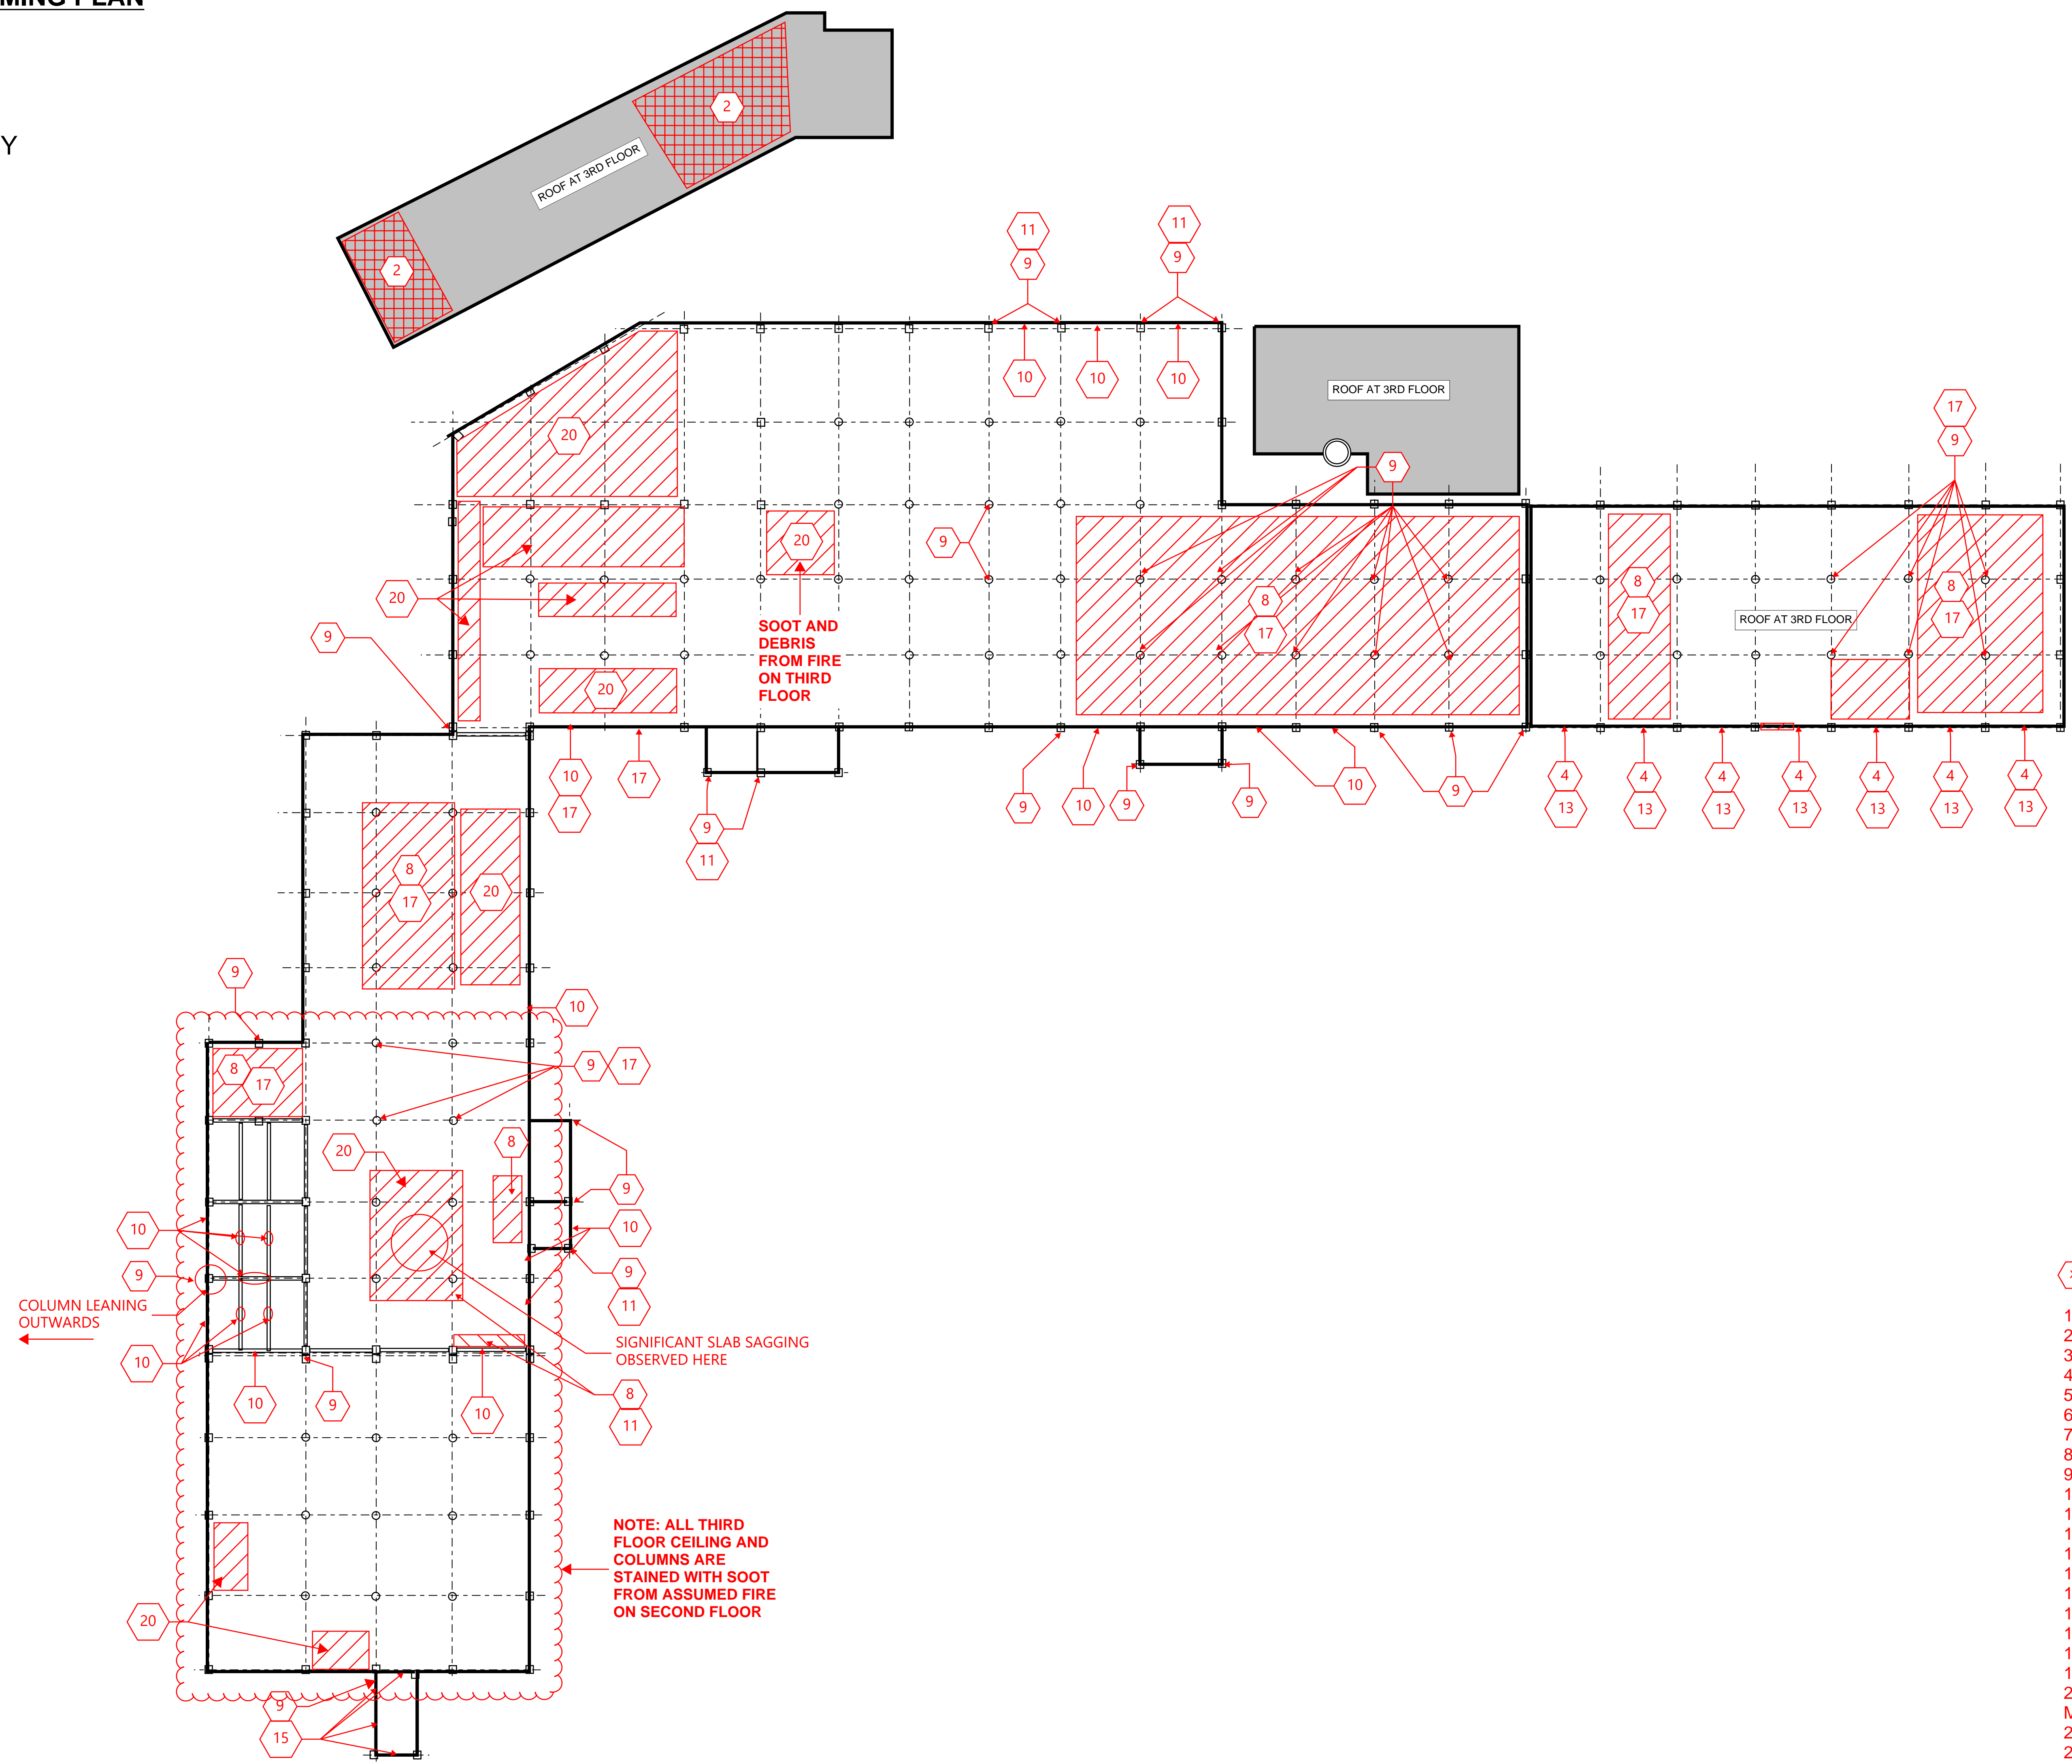
**THIRD FLOOR FRAMING PLAN  
SOUTH BUILDING**

- 4.3.9 The concrete beams located on Building 14's third floor framing plan should be repaired as soon as possible.
- 4.3.10 The third-floor slab of Building 13 has experienced significant deflection, spalling and corroded rebar in spalled concrete locations. Remove stored materials that are located above this slab to reduce structural load and repair the slab.

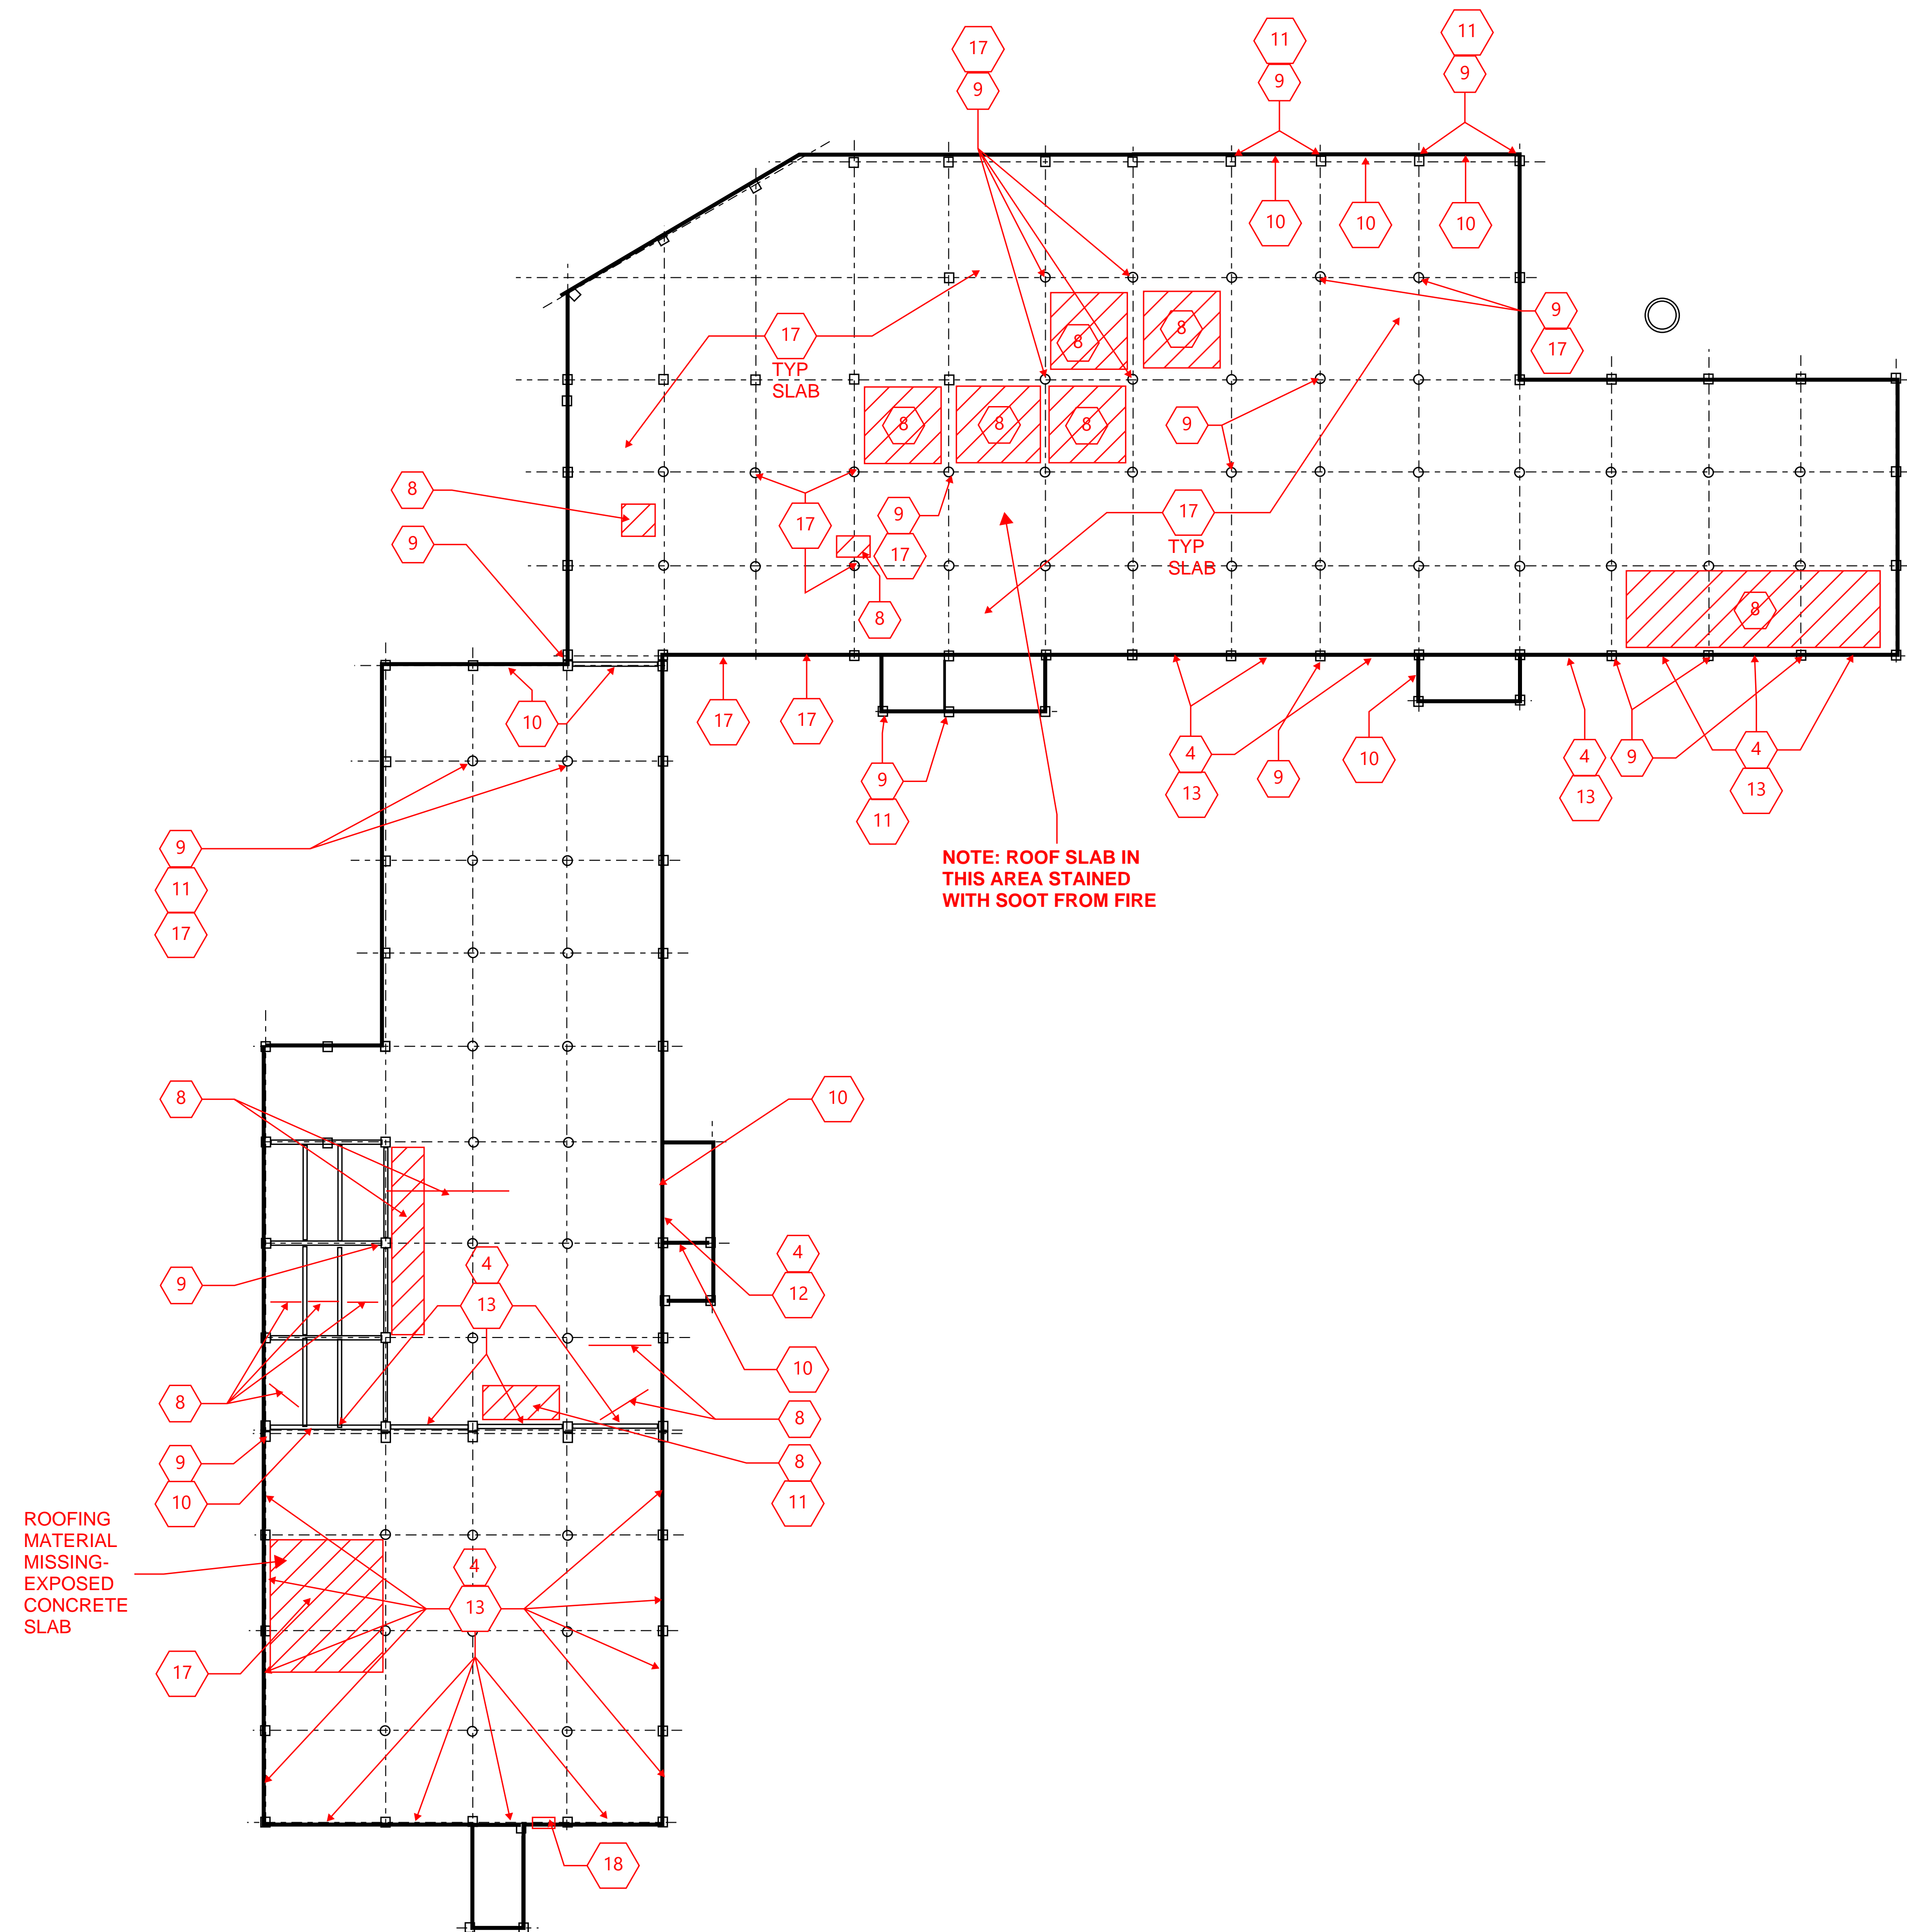
**ROOF FRAMING PLAN  
SOUTH BUILDING**

- 4.3.11 Based on the extent of roof structural deterioration and/or failure, the metal edged gypsum plank roof deck on Building 21 should be removed and replaced as soon as possible to prevent further failure.
